# Seepage Measured at 17 Locations in Newtown Creek, New York

## U.S. Geological Survey Administrative Report to U.S. Environmental Protection Agency, Special Projects Branch, New York, New York

Data collected May 19–June 19, 2015

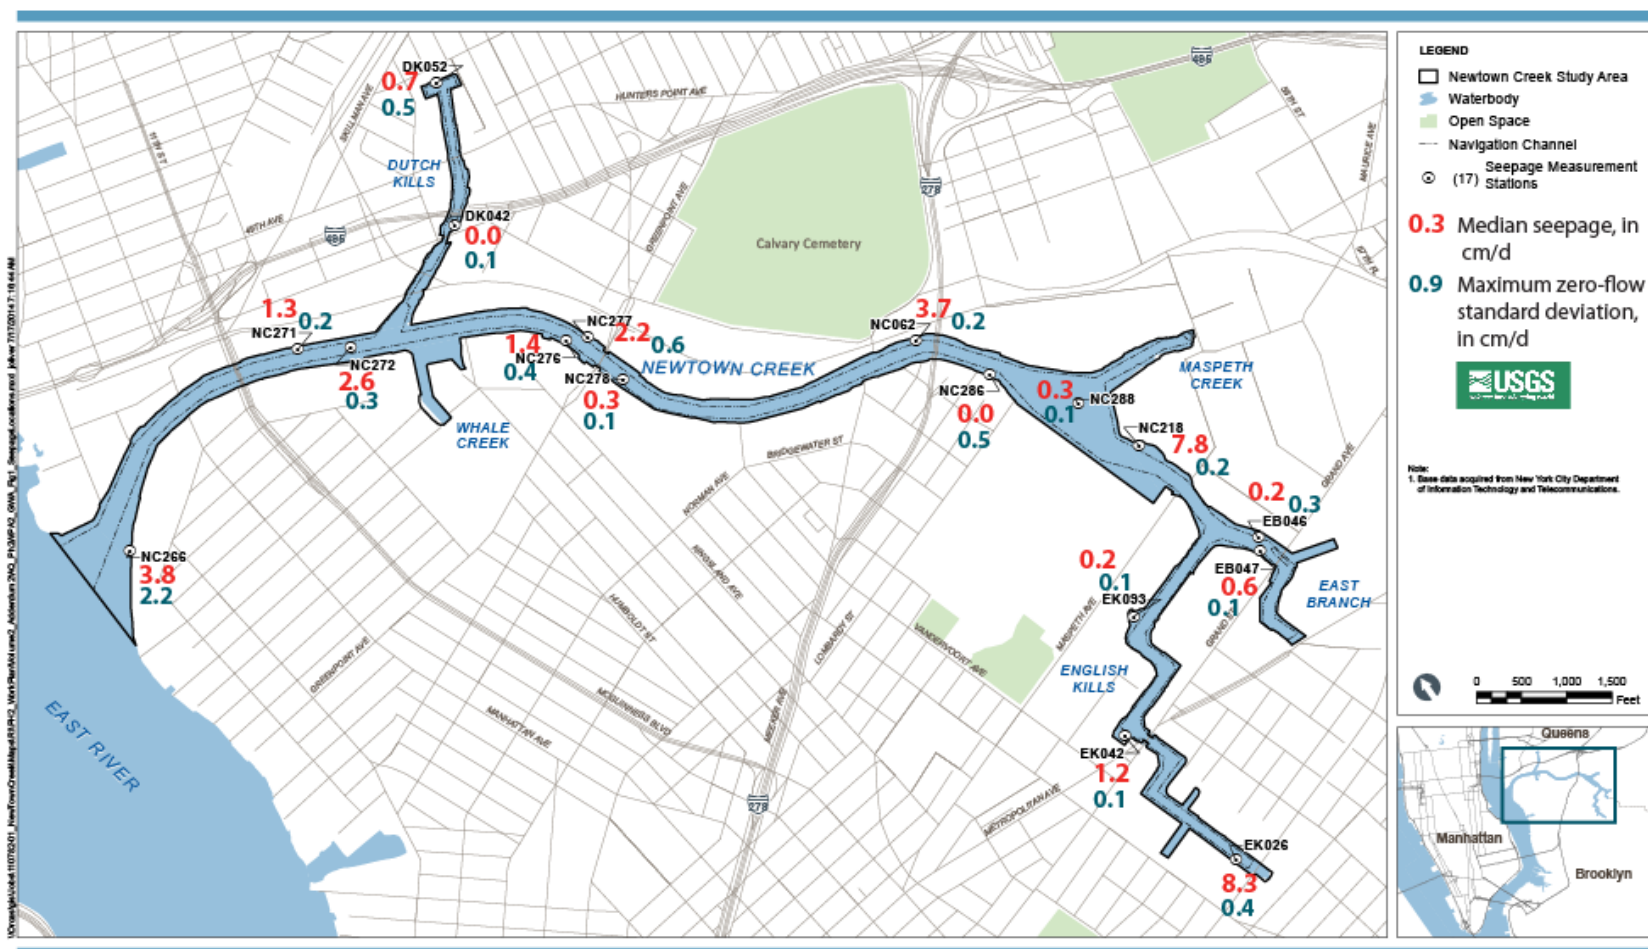
Figure 1 – Seepage-measurement locations at Newtown Creek.  
 Values in red are median seepage rates during sensor deployments.  
 Values in blue are maximum standard deviations during periods of induced zero flow through the flowmeter. [cm/d, centimeters per day]

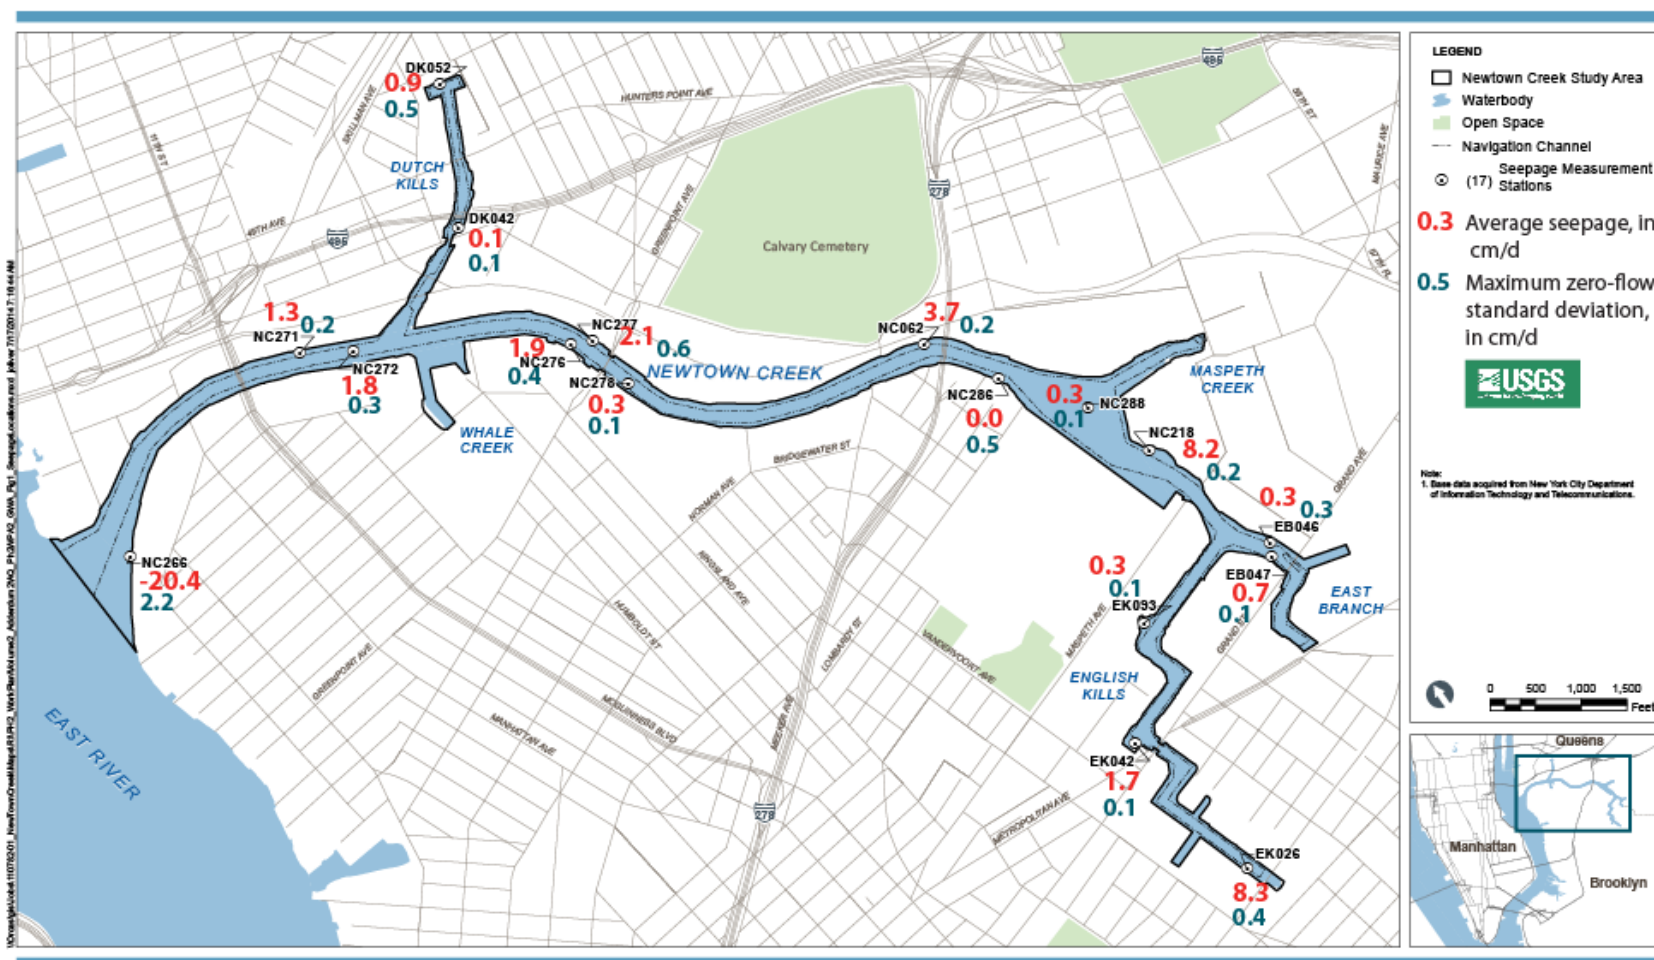
Figure 2 – Seepage-measurement locations at Newtown Creek.  
 Values in red are average seepage rates during sensor deployments.  
 Values in blue are maximum standard deviations during periods of induced zero flow through the flowmeter. [cm/d, centimeters per day]

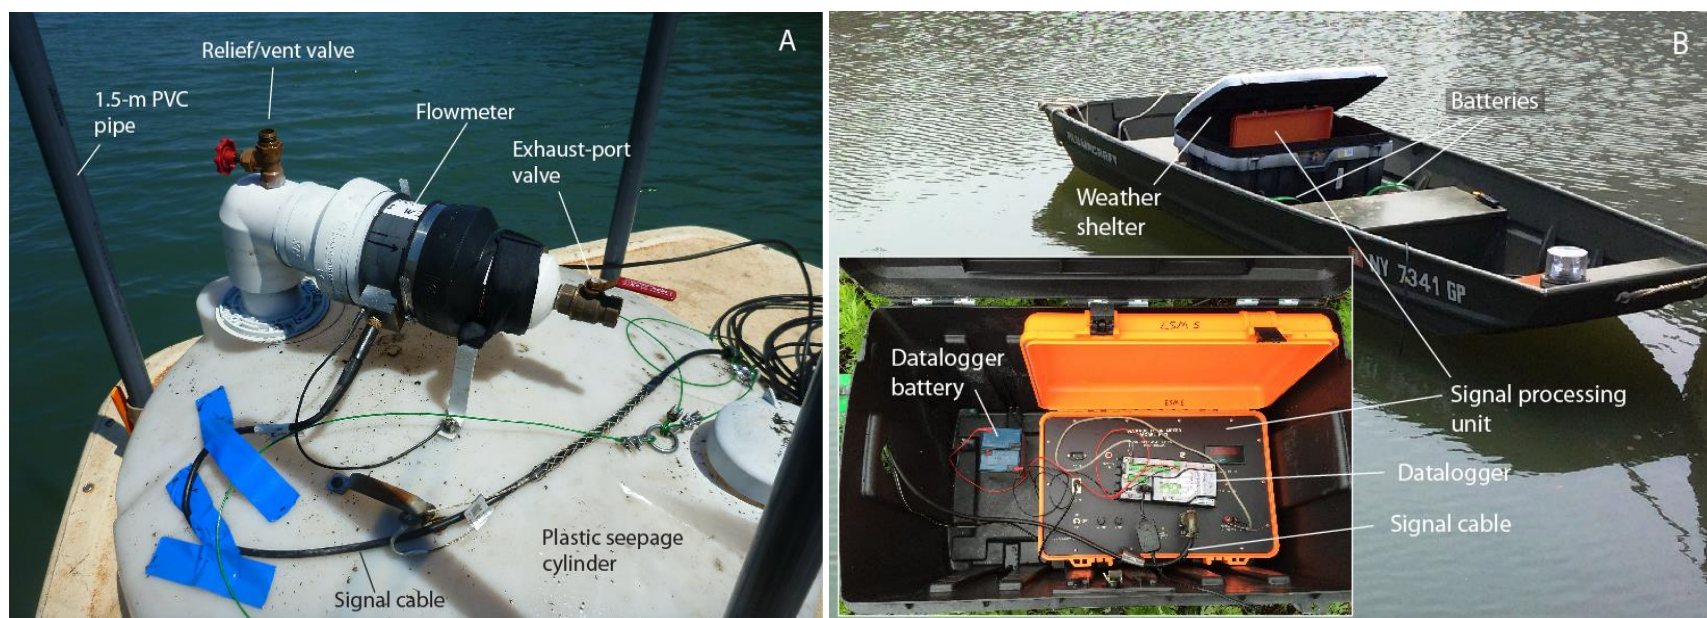
**Figure 3.** Photos of an electromagnetic seepage meter deployed at Newton Creek. A, Seepage cylinder and flowmeter prior to being lowered onto the sediment bed; photograph also shows the three polyvinyl chloride (PVC) pipes that will be pushed into the sediment by a diver. B, Signal-processing unit in an anchored boat; inset photograph shows close-up of weather shelter interior.

Three ESM systems were available for use at Newtown Creek. Aluminum cylinders covering 9,260 square centimeters (cm<sup>2</sup>) of sediment bed were used with two of the systems; a plastic cylinder covering 8,938 cm<sup>2</sup> was used with the third system. At each measurement location, the seepage cylinder and attached flowmeter were lowered slowly onto the sediment to minimize sediment disturbance. A hard-hat diver observed and facilitated cylinder installation to ensure that the bottom edge of the seepage cylinder was inserted at least 5 centimeters but no more than 20 centimeters into the sediment bed along the entire cylinder perimeter. The diver pushed 1.5-m lengths of polyvinyl chloride (PVC) pipe vertically into the sediment until refusal. Each of the three pipes was then secured to the seepage cylinder with a set screw to eliminate the possibility of any movement of the seepage cylinder in the soft sediment. Once installation was complete, the diver closed a relief valve designed to vent any gas released from the sediment and, with the flowmeter exhaust-port valve open, the meter was ready to log seepage.

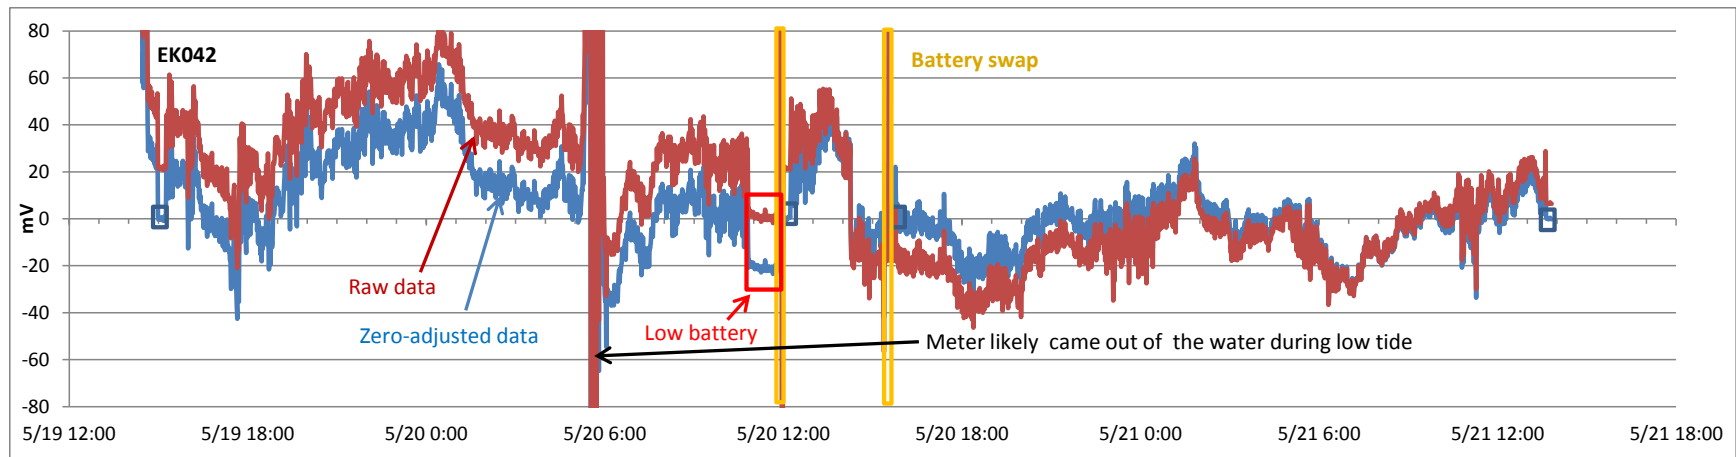
**Figure 4.** Effect of correcting seepage-meter output using zero-flow-offset measurements at EK042. Unadjusted data shown in red and zero-flow-adjusted data shown in blue. Blue rectangles indicate periods when flow was zeroed. (mV, millivolts)

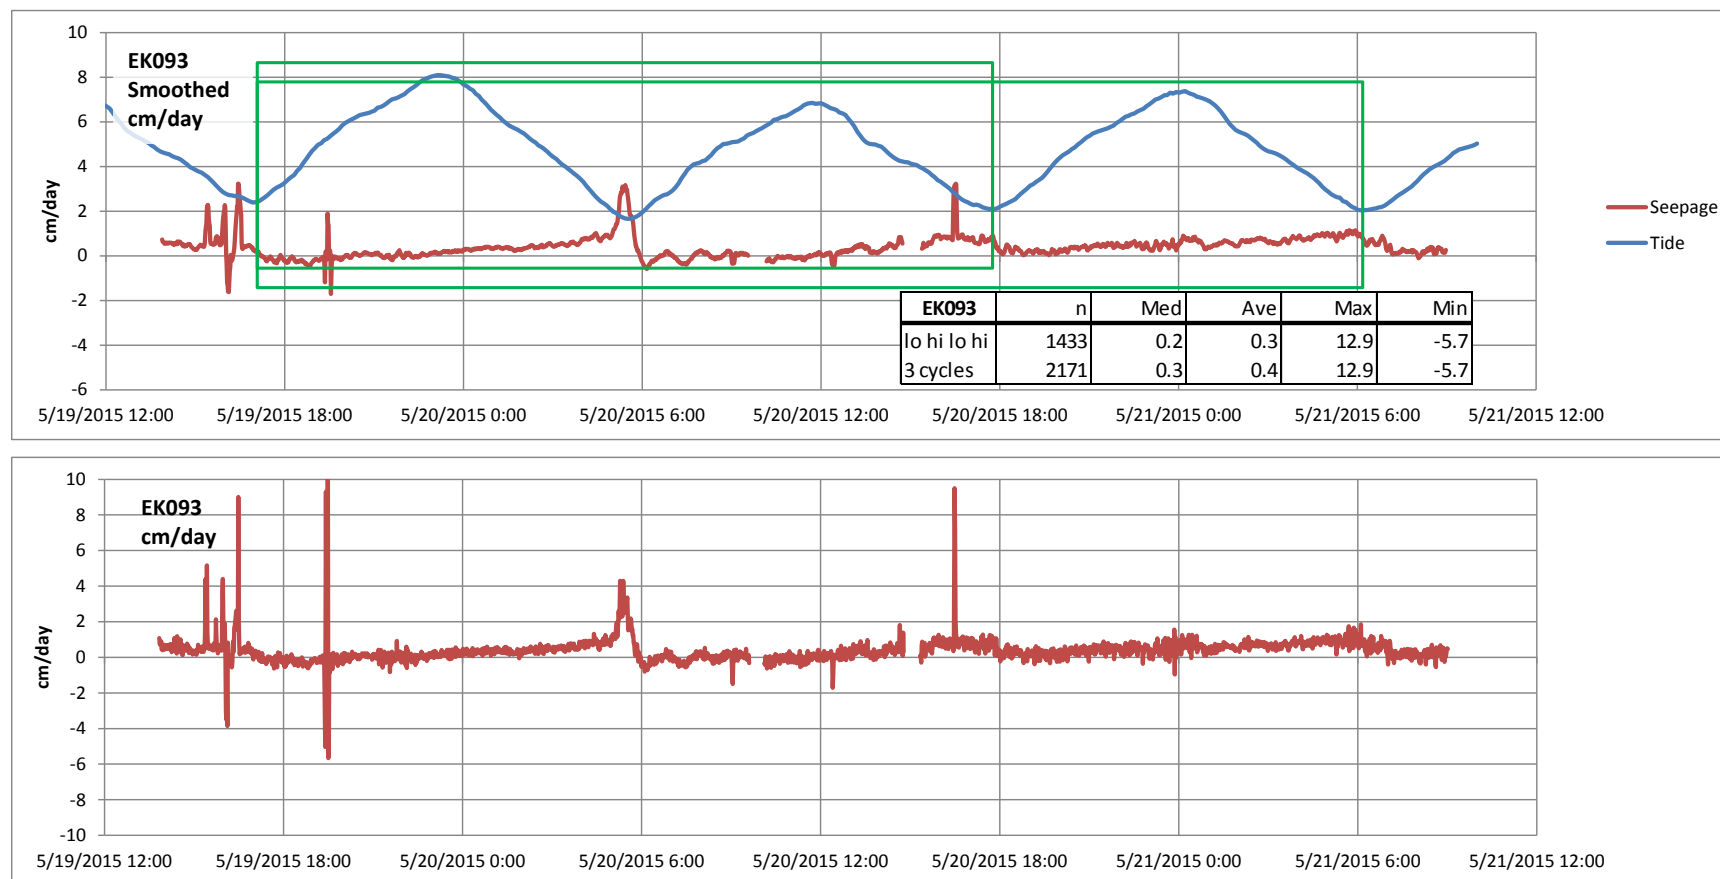
**Figure 5.** Seepage measured each minute during deployment at EK093, in centimeters per day. The upper plot displays smoothed seepage data based on a 7-minute moving average and relative tide in feet. The lower plot presents the actual 1-minute values. The green rectangles indicate the duration of the data-summary periods. In the inset table, “lo hi lo hi” indicates two complete tidal cycles beginning and ending with low tide, and “3 cycles” indicates that seepage was measured over three tidal cycles. (cm/d, centimeters per day; n, number of 1-minute values; Med, median of n values; Ave, average of n values; Max, maximum of n values; Min, minimum of n values)

Seepage was slow, relatively steady, and mostly upward at EK093 (fig. 5). The median value was 0.2 to 0.3 cm/d, depending on the period of analysis. The spikes in the dataset did not have an appreciable effect on the summary statistics. Even after discarding 101 values (see “Censored” in table 7) to remove data spikes centered around May 19, 2015, at 19:25 and May 20, 2016, at 05:20 and 16:30, all summary statistics remain virtually the same except for maximum, minimum, and 0.75 quartile values.

Upward seepage increased slightly during each falling tide (fig. 5). Upward seepage was most pronounced during the lowest of the low tides on the morning of May 20, 2015. Seepage increased substantially just prior to the lowest-tide nadir. Once the tide began rising, seepage decreased and became slightly downward. This stronger tidal response occurred only during the lowest tide during the measurement period. Similar seepage response to extreme low tides has also been observed in Puget Sound, Washington (Simonds and others, 2008).

Very slow downward seepage occurred during two of the three rising tides shown in the chart. Seepage was upward during the third tidal cycle and increased steadily during the rising and subsequent falling limbs from approximately 0.1 to approximately 0.5 cm/d. There is no obvious explanation for the upward and downward spikes just prior to 19:30 on May 19, 2015, and the upward spike at about 16:30 on May 20, 2015. However, benthic or epipelagic fauna can cause spikes when they crawl or swim through the orifice of the electromagnetic flowmeter.

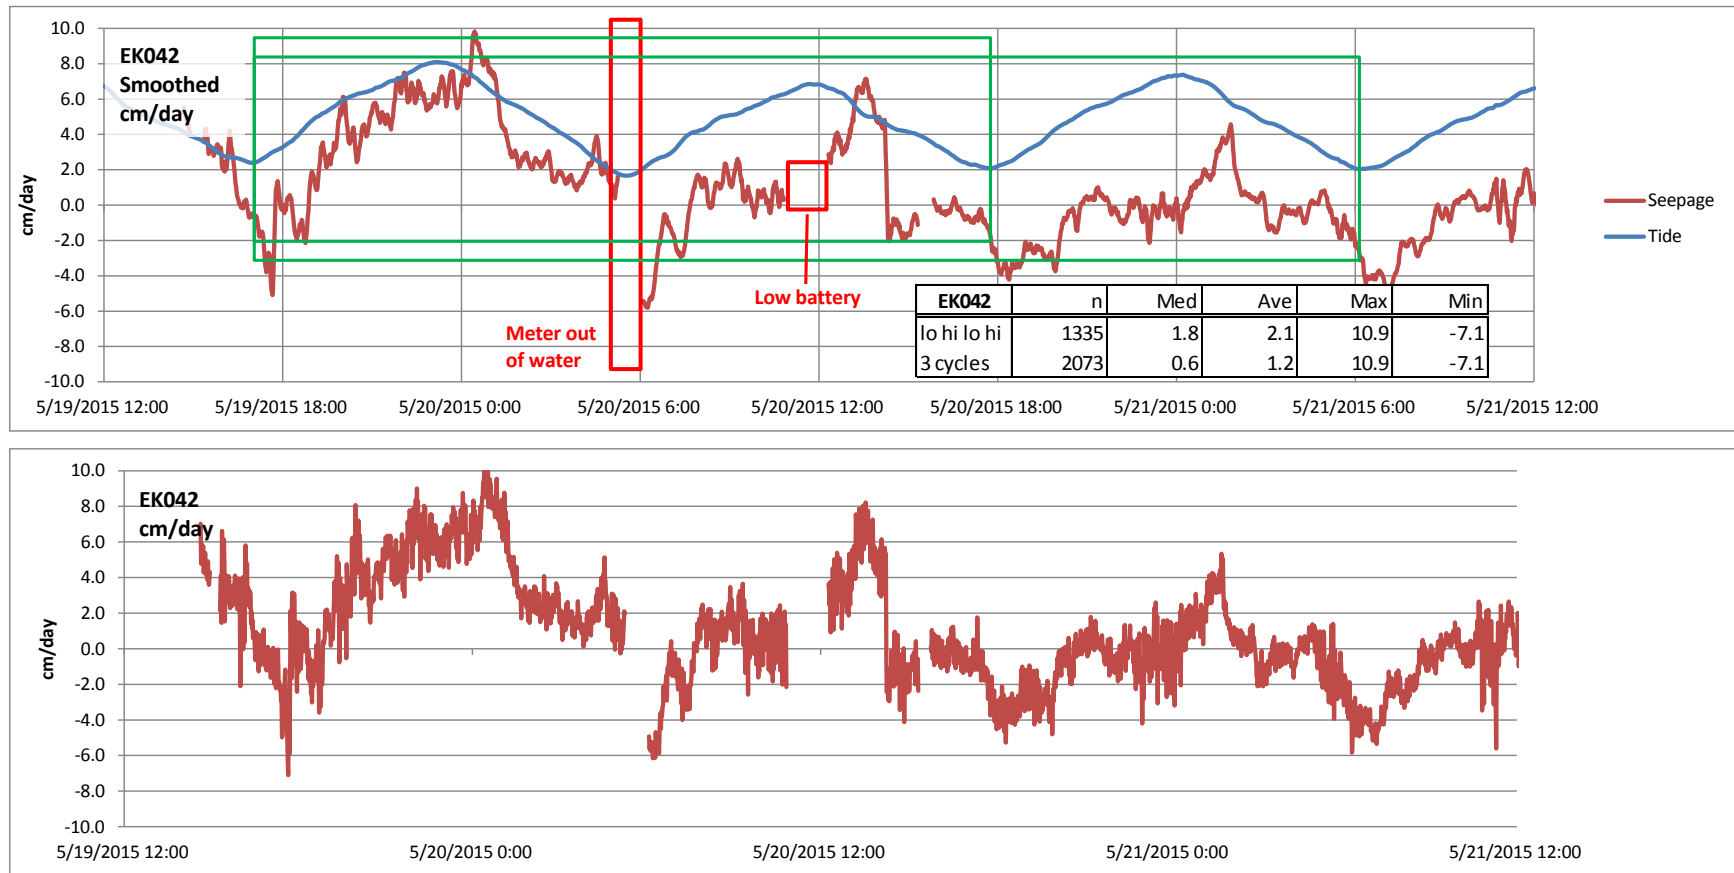
**Figure 6.** Seepage measured each minute during deployment at EK042, in centimeters per day. The upper plot displays smoothed data based on a 7-minute moving average and relative tide in feet. The lower plot presents the actual 1-minute values. The green rectangles indicate the duration of the data-summary periods. In the inset table, “lo hi lo hi” indicates two complete tidal cycles beginning and ending with low tide, and “3 cycles” indicates that seepage was measured over three tidal cycles. (cm/d, centimeters per day; n, number of 1-minute values; Med, median of n values; Ave, average of n values; Max, maximum of n values; Min, minimum of n values)

Median seepage originally determined at EK042 ranged from 0.5 to 1.6 cm/d, depending on whether two or three tidal cycles were analyzed. However, two periods of questionable data may have affected summary statistics. The large variability from about 05:30 to 05:50 on May 20,

2015, (fig. 6) was likely caused by the water surface falling to near the orifice of the electromagnetic flowmeter; water would be able to pulse through the flowmeter with the passage of small waves and ripples in the water surface. A low battery was responsible for erroneous data collection beginning at 10:49 on May 20, 2015. If these two periods of erroneous data are discarded, seepage ranged from -7.1 to 10.9 cm/d. Median values increased slightly compared to the original data and ranged from 0.6 to 1.8 cm/d. These are the values shown in the table embedded in the upper chart in figure 6 and in table 1.

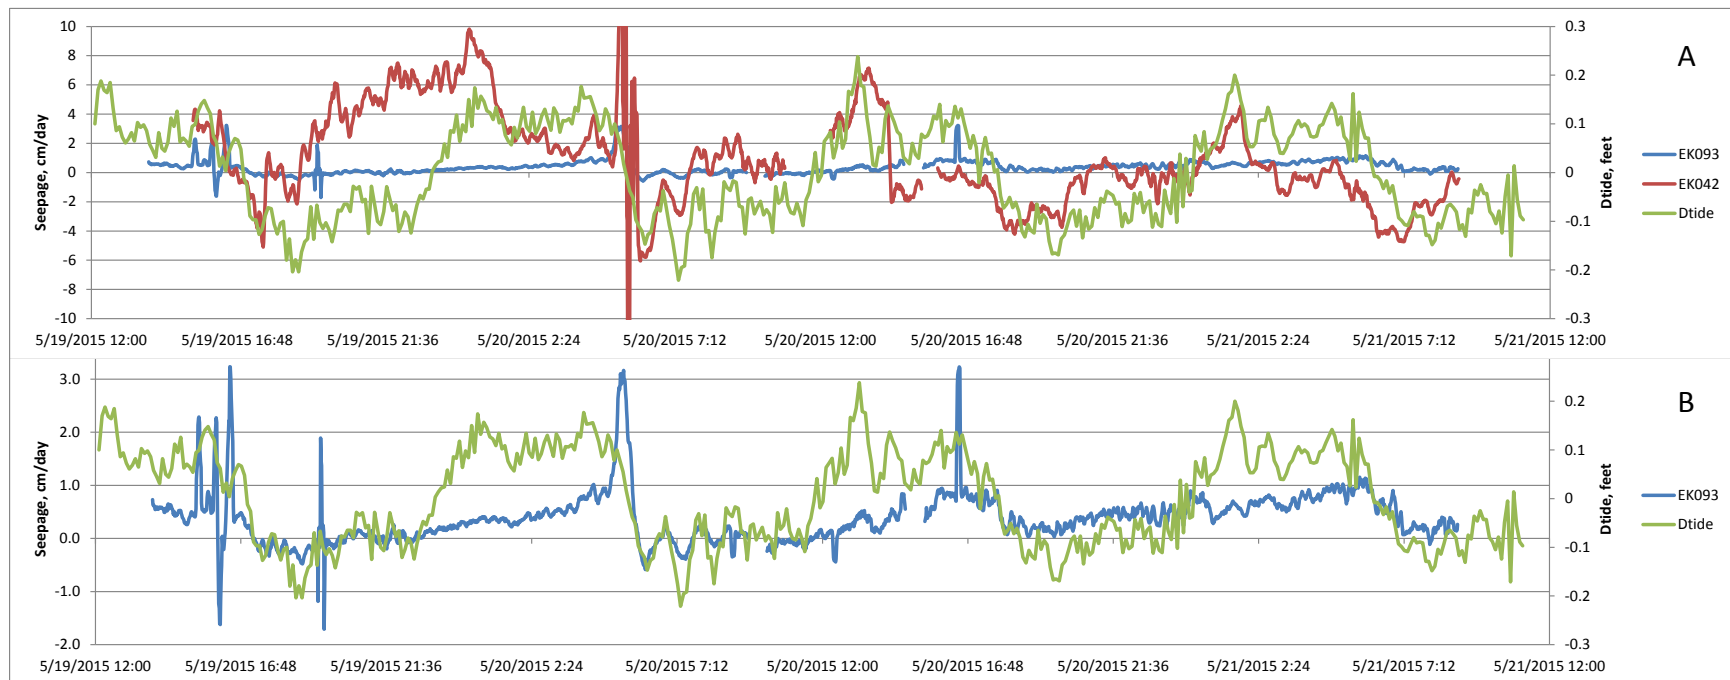
**Figure 7.** (A) Smoothed seepage measured at EK042 and EK093, in centimeters per day (cm/d), with the previous tidal value minus the current tidal value (Dtide), in feet, plotted on the right axis. (B) Variability at EK093 is plotted over a narrower range.

Values were substantially variable, and seepage was responsive to tides. Upward seepage increased steadily during each rising tide until 1 to 2 hours after high tide; seepage then decreased substantially, sometimes at a rapid rate. Downward seepage occurred generally at about the halfway point between high and low tide, but seepage did not become downward on May 20, 2015, until the low-tide nadir (fig. 6). Much of the short-term variability in the seepage data can be explained by small changes in the rate of surface-water stage increase or decrease during each tidal cycle. If the difference in stage from one measurement to the next is plotted instead of stage, as shown in figure 7, inflections in the change in stage correlate well with inflections in seepage rate. Furthermore, the timing of inflections in seepage is similar for both locations shown in figure 7. The much smaller range in variability at EK093 also correlates with changes in the rate of tidal change. This correlation is particularly apparent from 06:00 to 10:00 on May 20, 2015, and from 06:00 to 09:00 on May 21, 2015 (fig. 7B).

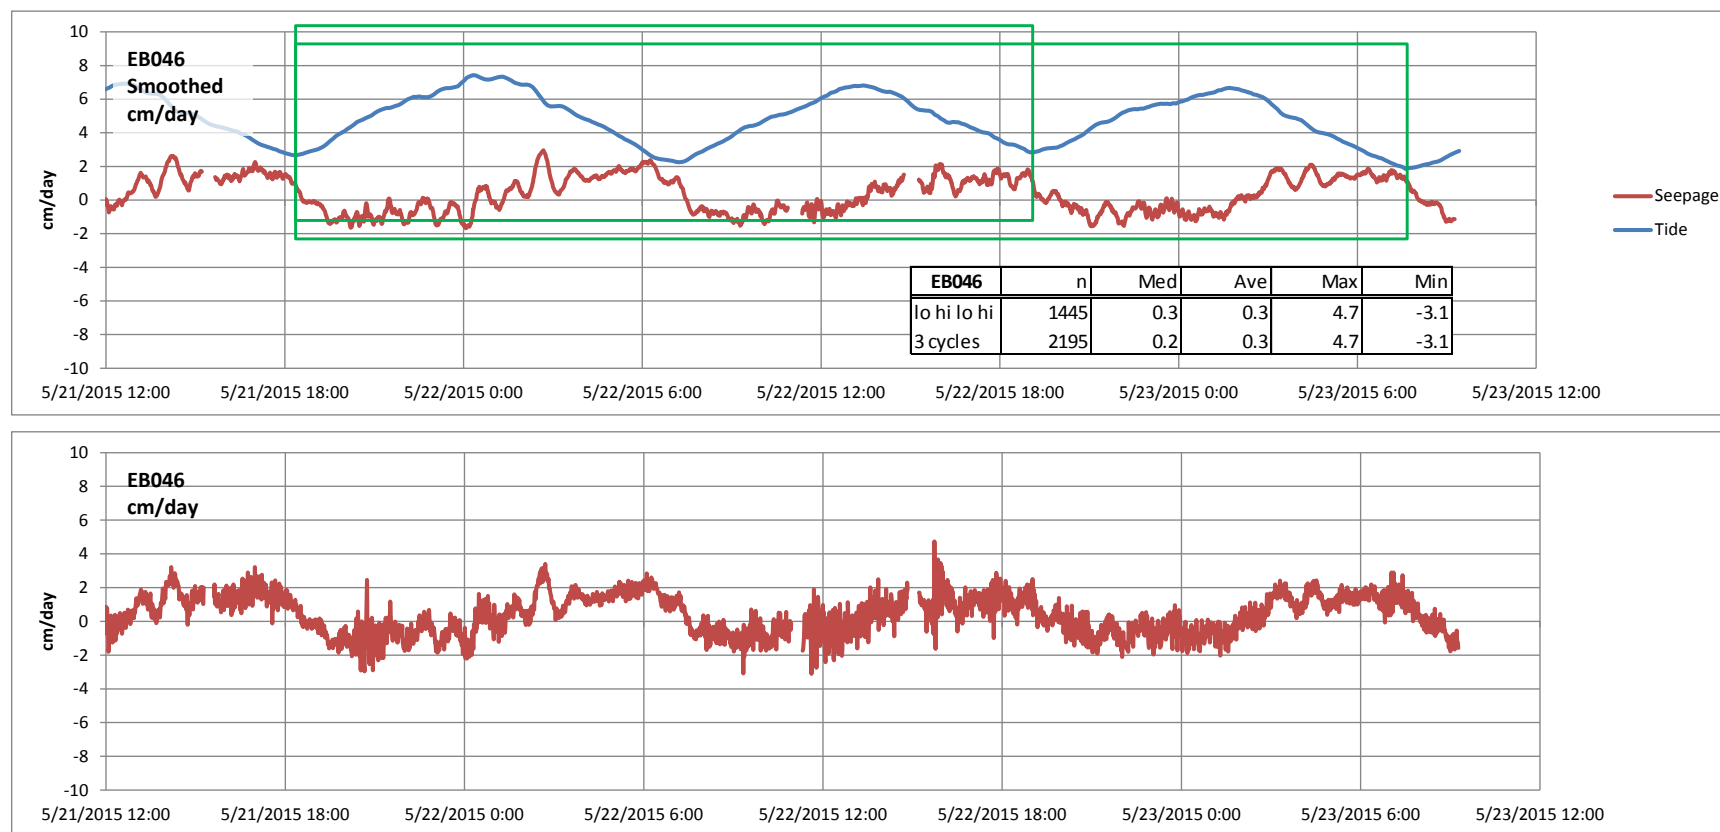
**Figure 8.** Seepage measured each minute during deployment at EB046, in centimeters per day. The upper plot displays smoothed data based on a 7-minute moving average and relative tide, in feet. The lower plot presents the actual 1-minute values. The green rectangles indicate the duration of the data-summary periods. In the inset table, “lo hi lo hi” indicates two complete tidal cycles beginning and ending with low tide and “3 cycles” indicates that seepage was measured over three tidal cycles. (cm/d, centimeters per day; n, number of 1-minute values; Med, median of n values; Ave, average of n values; Max, maximum of n values; Min, minimum of n values)

Seepage at EB046 was slow, ranging from -3.1 to 4.7 cm/d (fig. 8). Median seepage was slightly upward at 0.2 or 0.3 cm/d, depending on the analysis period. As at other sites near the eastern end of Newtown Creek, seepage became slightly downward shortly after the beginning of a rising tide and became slightly upward at or soon after tidal apex. Transition from upward to downward seepage was particularly rapid at or just after tidal nadir.

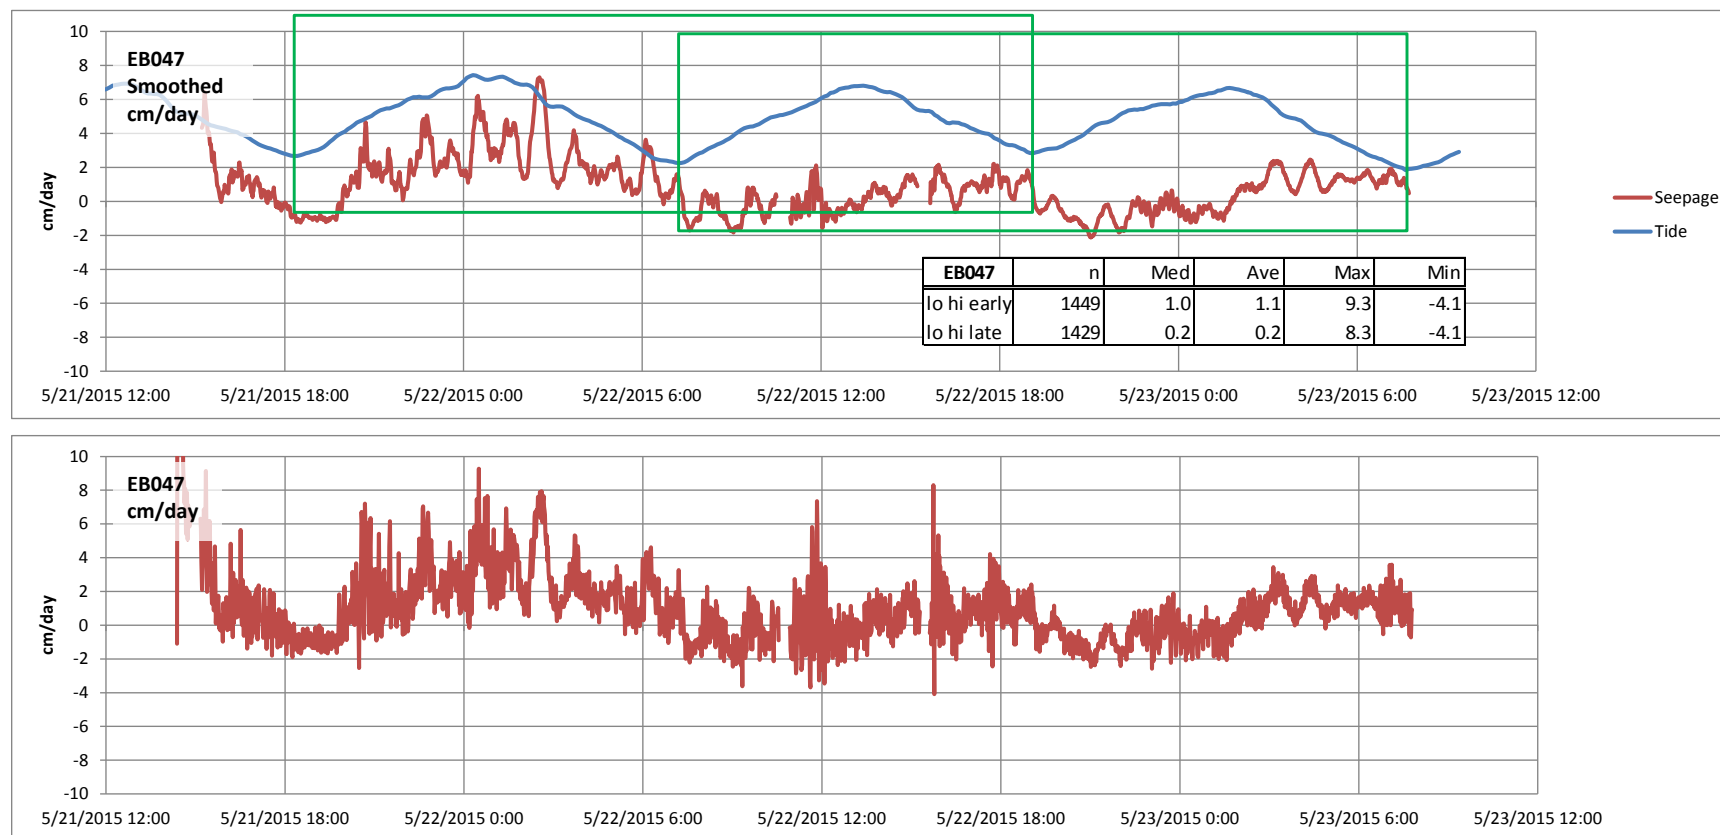
**Figure 9.** Seepage measured each minute during deployment at EB047, in centimeters per day. The upper plot displays smoothed data based on a 7-minute moving average and relative tide, in feet. The lower plot presents the actual 1-minute values. The green rectangles indicate the duration of the data-summary periods. In the inset table, “lo hi” indicates one complete tidal cycle beginning and ending with low tide, and “early” or “late” indicates the timing of the analysis period. (cm/d, centimeters per day; n, number of 1-minute values; Med, median of n values; Ave, average of n values; Max, maximum of n values; Min, minimum of n values)

A slight decrease in seepage was detected during the EB047 measurement period, hence the early- and late-period analyses shown in figure 9. Comparing tidal cycles 1 and 2 (early) to cycles 2 and 3 (late) shows that median seepage decreased from 1.0 to 0.2 cm/d. Extremes ranged from -4.1 to 9.3 cm/d. Seepage was generally downward shortly after tidal nadir and then transitioned to upward seepage before tidal apex. Seepage was generally fastest from about 20:00 on May 21, 2015, until 04:00 on May 22, 2015.

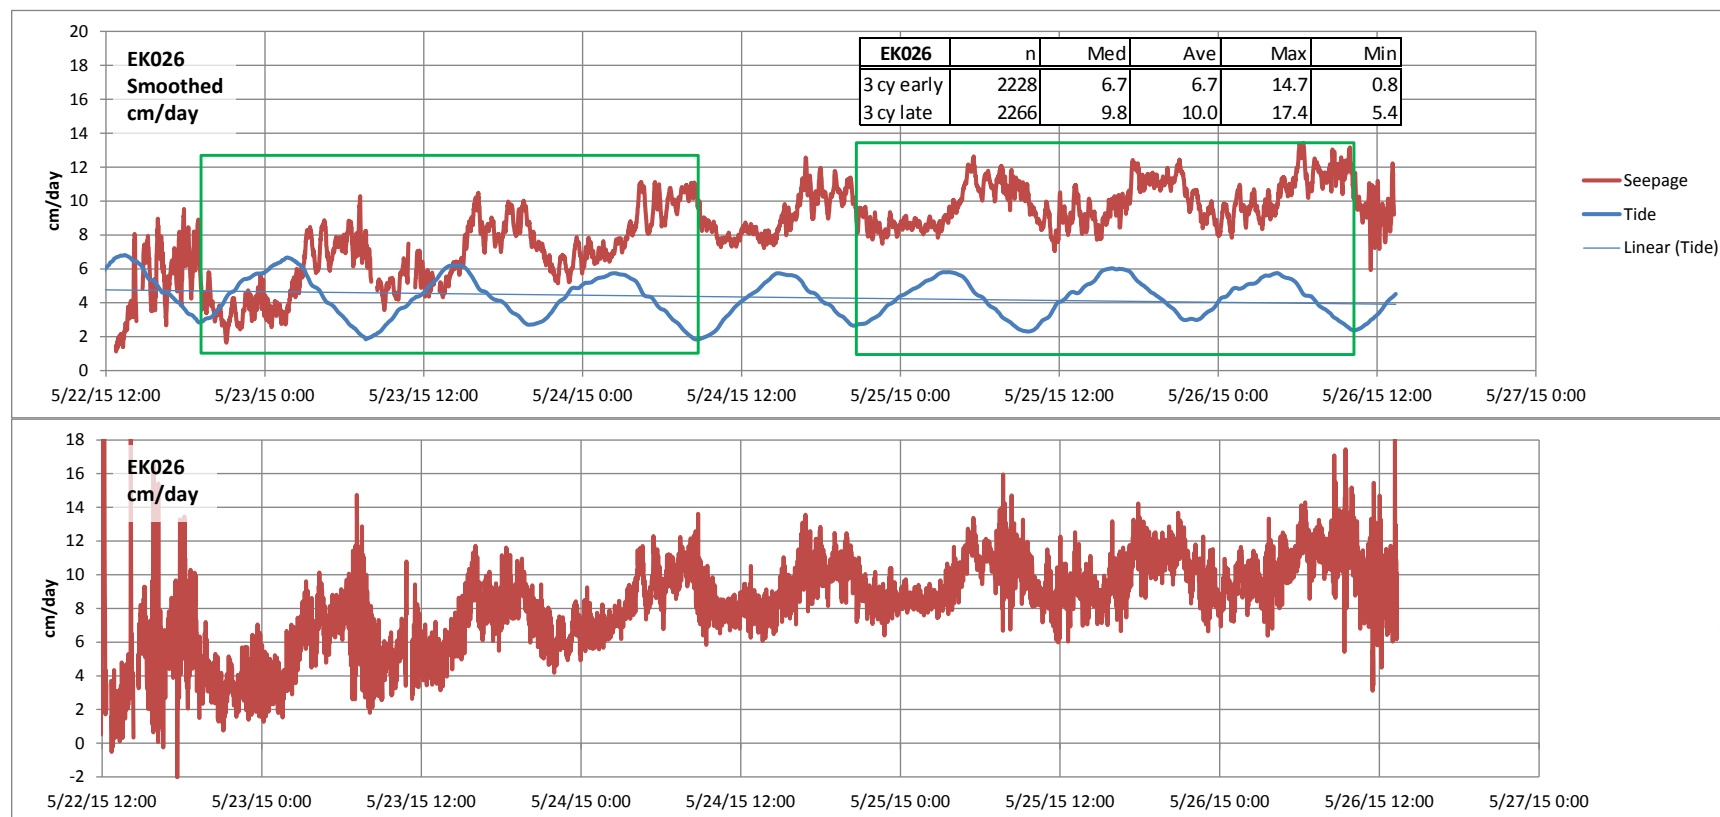
**Figure 10.** Seepage measured each minute during deployment at EK026, in centimeters per day. The upper plot displays smoothed data based on a 7-minute moving average and relative tide, in feet. A simple linear regression of tide is also presented in blue. The lower plot presents the actual 1-minute values. The green rectangles indicate the duration of the data-summary periods. In the inset table, “3 cy early” and “3 cy late” indicate the number of tidal cycles during which seepage was measured and the timing of the analysis period. (cm/d, centimeters per day; n, number of 1-minute values; Med, median of n values; Ave, average of n values; Max, maximum of n values; Min, minimum of n values; cy, cycles)

Seepage at location EK026 was relatively fast, responded to tides, and increased gradually during the measurement period (fig. 10). This site had either the second largest or largest upward seepage rate, depending on whether the early or late part of the dataset is analyzed. A strong temporal trend was detected during a fairly long seven-tidal-cycle measurement period. Median seepage determined during the first three tidal cycles was 6.7 cm/d, and median seepage determined during the last three tidal cycles was 9.8 cm/d. The cause of the steady increase in seepage is unknown. A seepage meter slowly sinking into soft sediment could generate spurious upward flow. However, the diver checked the anchor pipes that held the seepage cylinder in place and they were firmly planted and secured to the seepage cylinder as designed. Another explanation could be an increasing hydraulic gradient that drives seepage discharge. Hydraulic gradient was not measured at this location. However, mean daily surface-water stage during the EK026 deployment decreased from approximately 4.75 feet to approximately 3.95 feet, as shown in the upper plot in figure 10. This decrease would result in an increasing hydraulic gradient assuming that the hydraulic head in groundwater adjacent to the water in Newtown Creek remained steady.

Seepage was almost always upwards, with just a few minutes of downward seepage indicated during the early part of the data-collection period. Seepage was very sensitive to changes in water-surface stage. The cyclic 2 to 3 cm/d variations in seepage during an approximately hourly time scale were caused by small changes in the rate of tidal change, perhaps because of wave amplification, as shown in figure 11. As previously shown in figure 7, Dtide in figure 11 is a plot of the differences between two incremental 1-minute tidal values.

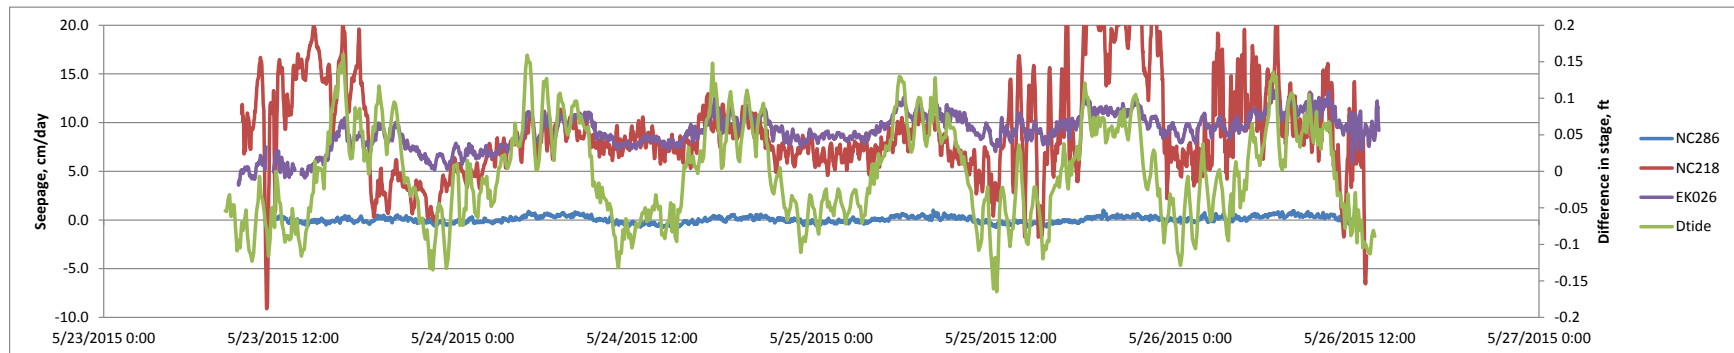
**Figure 11.** Smoothed seepage measured at NC286, NC218, and EK026, in centimeters per day (cm/d), with the previous tidal value minus the current tidal value (Dtide), in feet, plotted on the right axis.

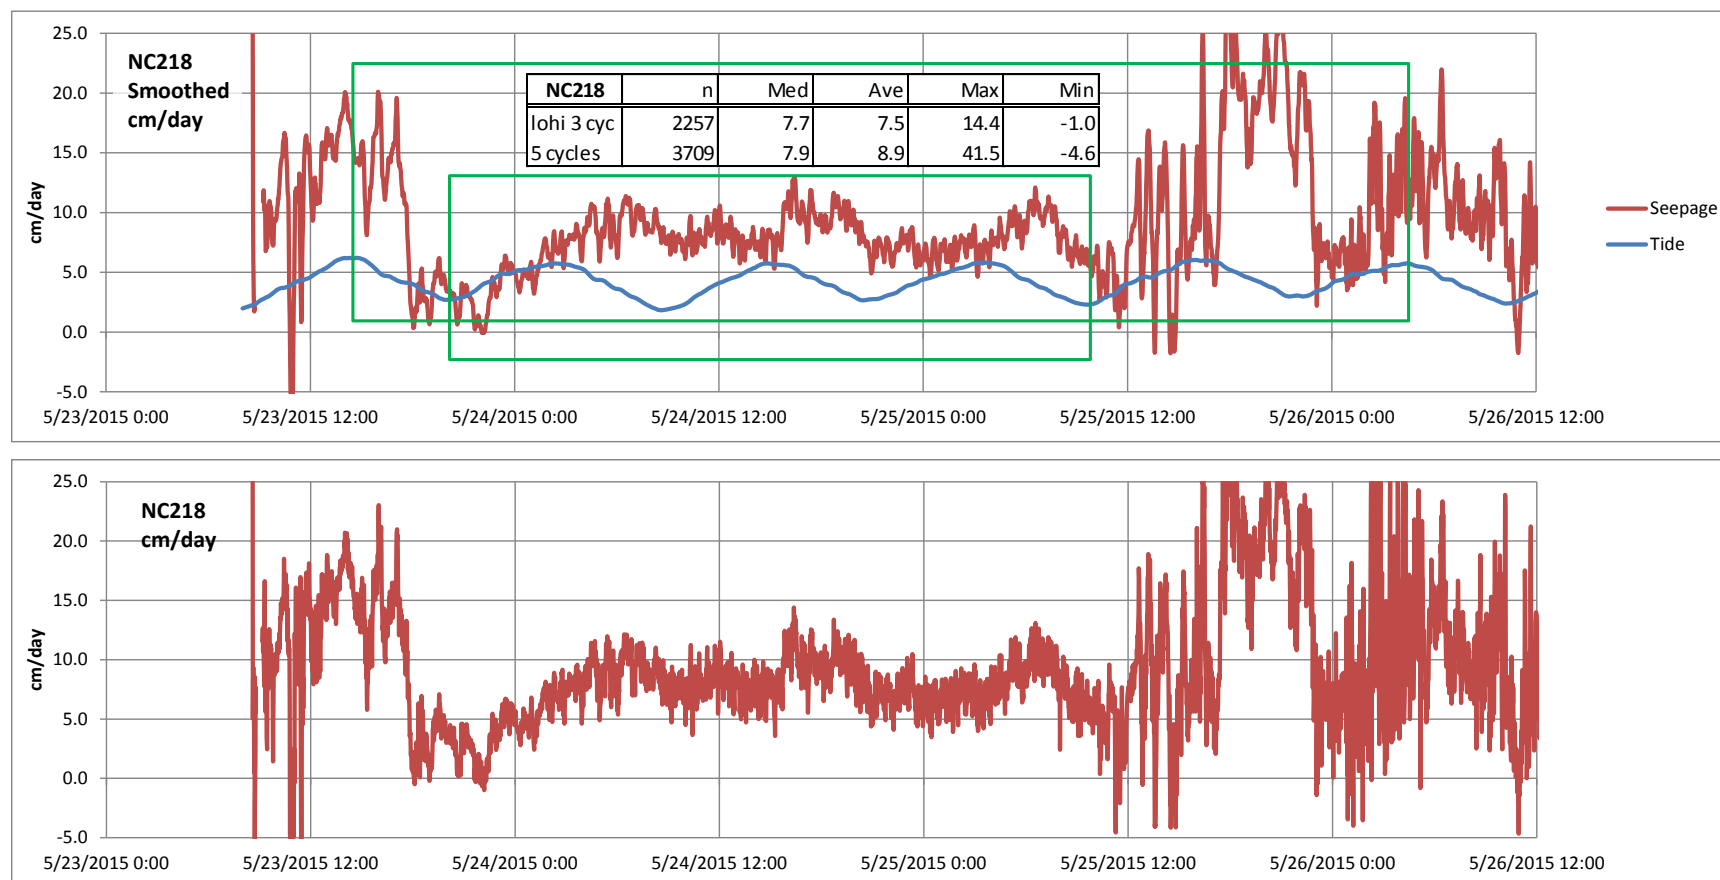
**Figure 12.** Seepage measured each minute during deployment at NC218, in centimeters per day. The upper plot displays smoothed data based on a 7-minute moving average, and relative tide, in feet. The lower plot presents the actual 1-minute values. The green rectangles indicate the duration of the data-summary periods. In the inset table, “lo hi” indicates one complete tidal cycle beginning and ending with low tide, and “3 cyc” and “5 cycles” indicate the number of tidal cycles during which seepage was measured. (cm/d, centimeters per day; n, number of 1-minute values; Med, median of n values; Ave, average of n values; Max, maximum of n values; Min, minimum of n values; cyc, cycles)

Seepage at NC218 was nearly always upward and was either the fastest or second fastest of the 17 measurement locations. Seepage was substantially variable during the 3-day data-collection period (fig. 12) with periods of large-amplitude variability interspersed with periods of lower-amplitude variability. The three-tidal-cycle analysis extended during a more stable period of measured seepage when seepage varied between -1.0 and 14.4 cm/d with a median value of 7.7 cm/d. A longer five-tidal-cycle analysis period indicated a range of seepage from -4.6 to more than 41 cm/d, but with a similar median value of 7.9 cm/d. Although short-term seepage variability changed substantially during the measurement period, no trend was evident during the data-collection period. The cause for larger (10 to 20 cm/d) seepage rates centered around 12:00 on May 23, 2015, and around 21:00 on May 25, 2015, is unknown. Wind has been related to either faster seepage or greater seepage variability (Rosenberry and others, 2013). However, as shown in figure 13, although both periods of faster seepage at NC218 were relatively windy, other periods were equally windy when seepage was much slower.

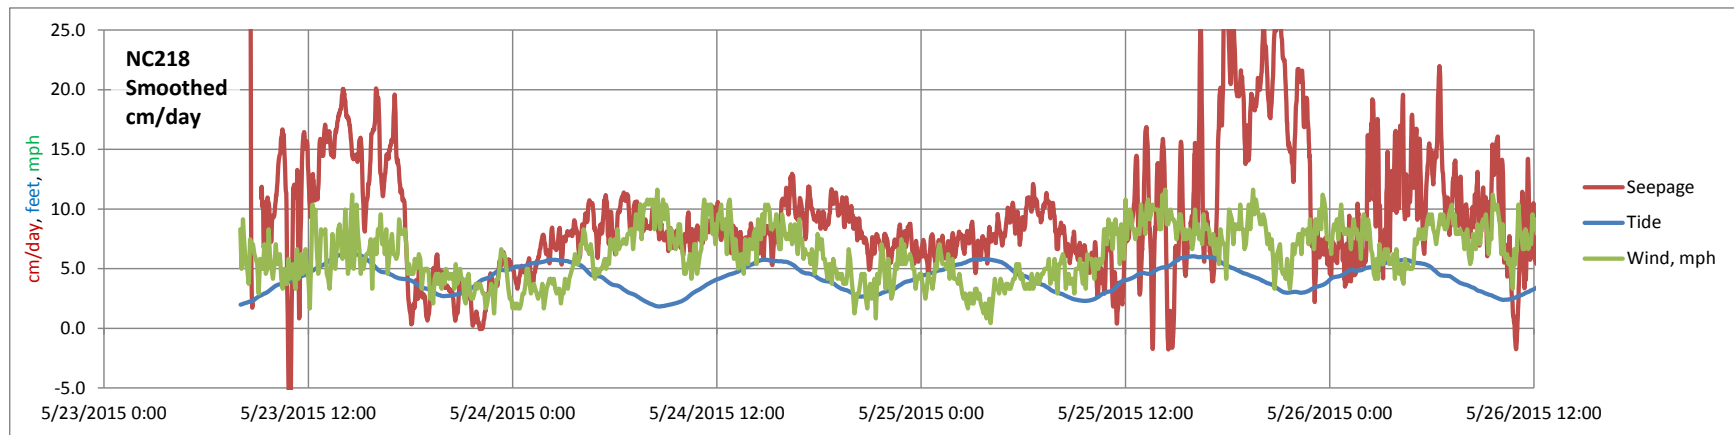
**Figure 13.** Smoothed seepage measured at NC218, in centimeters per day (cm/d); tide, in feet; and wind speed, in miles per hour (mph).

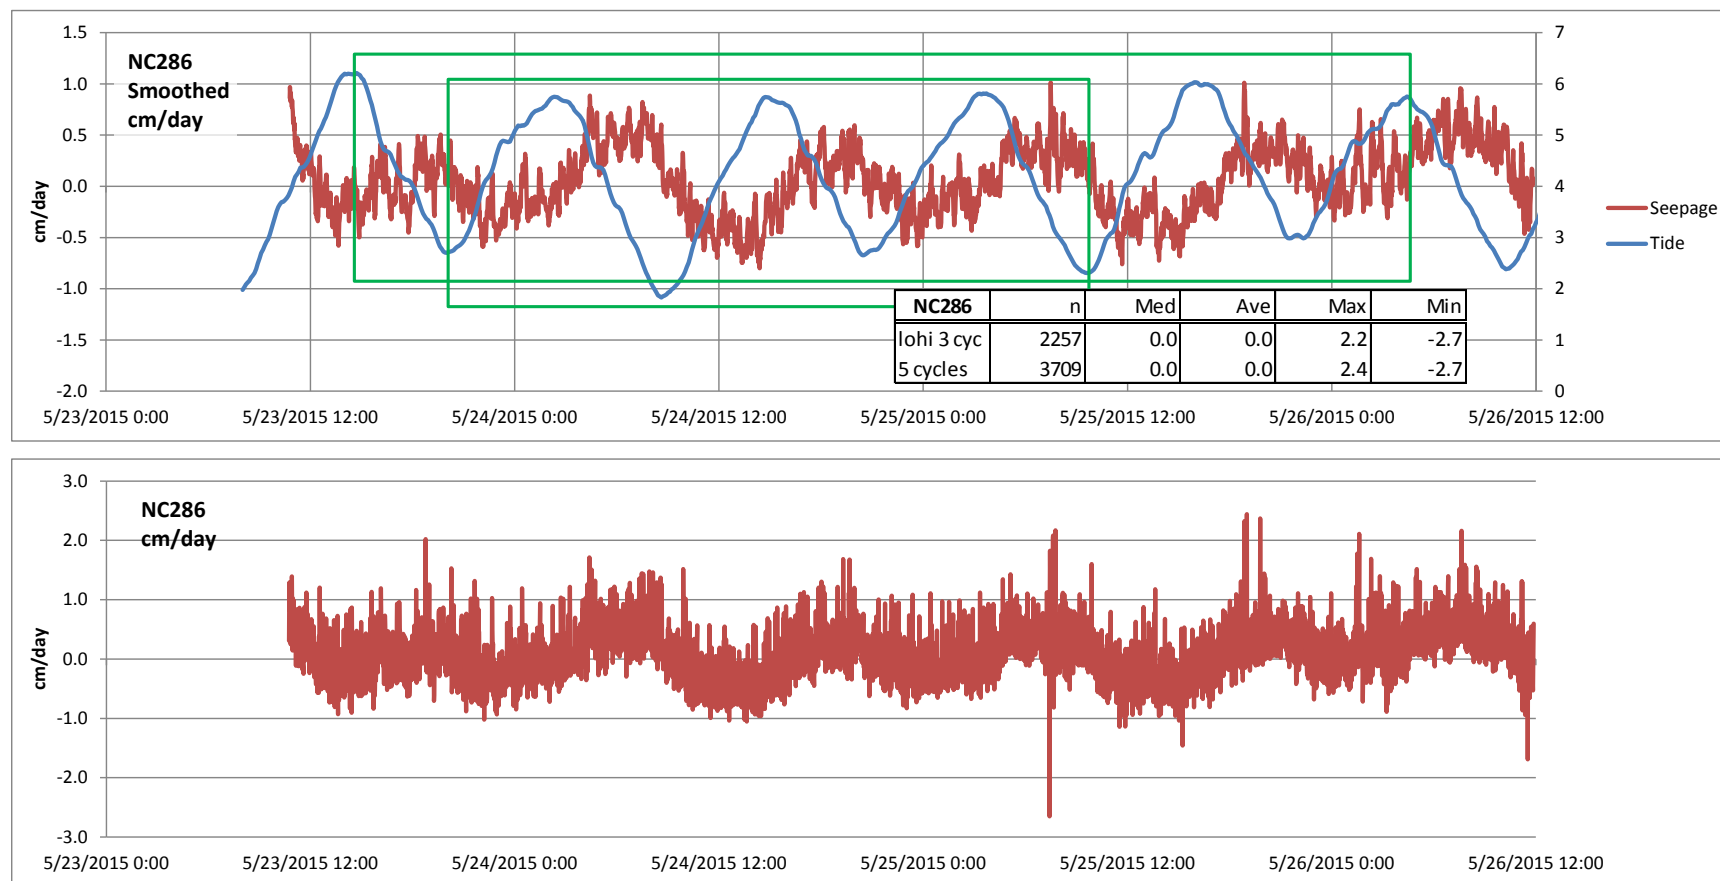
**Figure 14.** Seepage measured each minute during deployment at NC286, in centimeters per day. The upper plot displays smoothed data based on a 7-minute moving average, with relative tide, in feet, plotted on the right axis. The lower plot presents the actual 1-minute values. The green rectangles indicate the duration of the data-summary periods. In the inset table, “lo hi” indicates one complete tidal cycle beginning and ending with low tide, and “3 cyc” and “5 cycles” indicate the number of tidal cycles during which seepage was measured. (cm/d, centimeters per day; n, number of 1-minute values; Med, median of n values; Ave, average of n values; Max, maximum of n values; Min, minimum of n values; cyc, cycles)

Net seepage was zero at NC286 (fig. 14). A small response to tides was detected. Seepage commonly ranged between -0.5 and 0.5 cm/d with a phase lag relative to tide of approximately 4 hours. This was among the most stable and consistent datasets collected at Newtown Creek. The cause of the small downward spike shortly after 07:00 on May 25 is unknown.
