# Seepage Measured at 17 Locations in Newtown Creek, New York

## U.S. Geological Survey Administrative Report to U.S. Environmental Protection Agency, Special Projects Branch, New York, New York

Data collected May 19–June 19, 2015

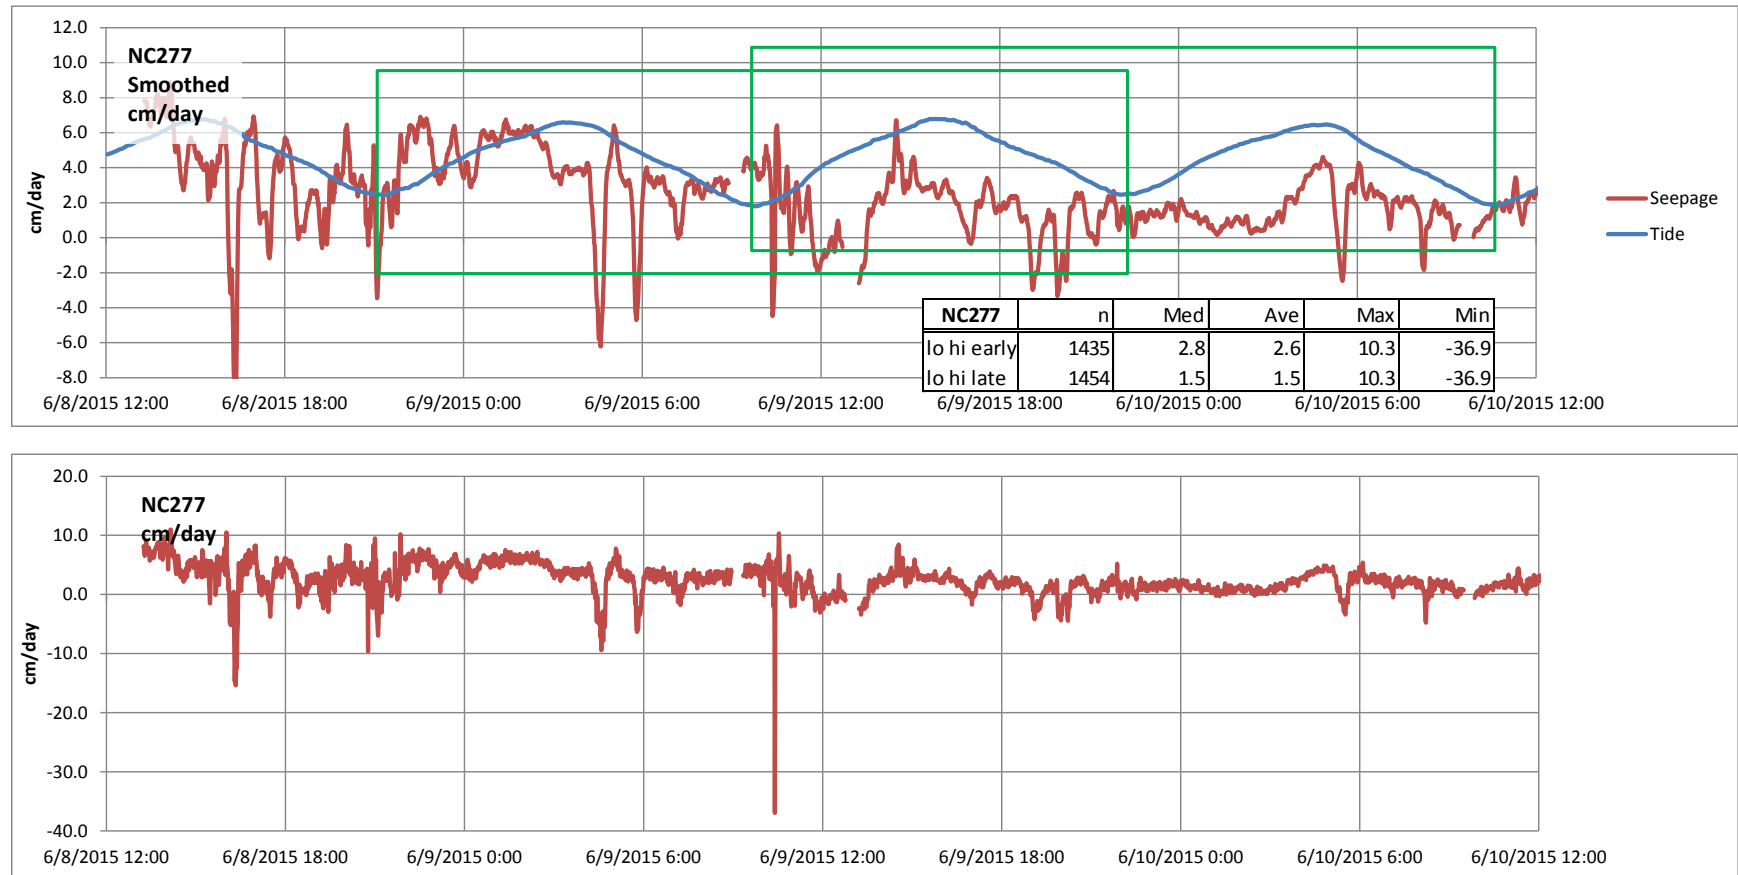
**Figure 15.** Seepage measured each minute during deployment at NC277, in centimeters per day. The upper plot displays smoothed data based on a 7-minute moving average, and relative tide, in feet. The lower plot presents the actual 1-minute values. The green rectangles indicate the duration of the data-summary periods. In the inset table, “lo hi” indicates one complete tidal cycle beginning and ending with low tide, and “early” or “late” indicates timing of an analysis period relative to the site-specific data-collection period. (cm/d, centimeters per day; n, number of 1-minute values; Med, median of n values; Ave, average of n values; Max, maximum of n values; Min, minimum of n values)

Moderately slow seepage at NC277 gradually became slower during the 2-day measurement period (fig. 15). Median seepage during the first two of three tidal cycles was 2.8 cm/d, and during the latter two-cycle period it decreased by nearly half to 1.5 cm/d. Seepage showed very little response to tides. Several periods of prolonged downward seepage were detected, most persisting for 20 to 30 minutes (fig. 16). Examples include downward spikes at 16:22 on June 8, 2015, and at 04:36 and 05:47 on June 9, 2015. Most of these downward spikes occurred 1 hour or 3 hours after high tide, and no downward spikes were detected during a rising tide. None of these departures from more typical seepage rates is related to changes in surface-water stage. The largest downward seepage spike, at 10:24 on June 9, 2015, (fig. 15, lower chart) occurred only 2 minutes prior to a similar but smaller downward spike measured at NC278 (fig. 17), located across the channel. The causes for these nearly coincident departures are unknown but, because of their proximity, they may be related.

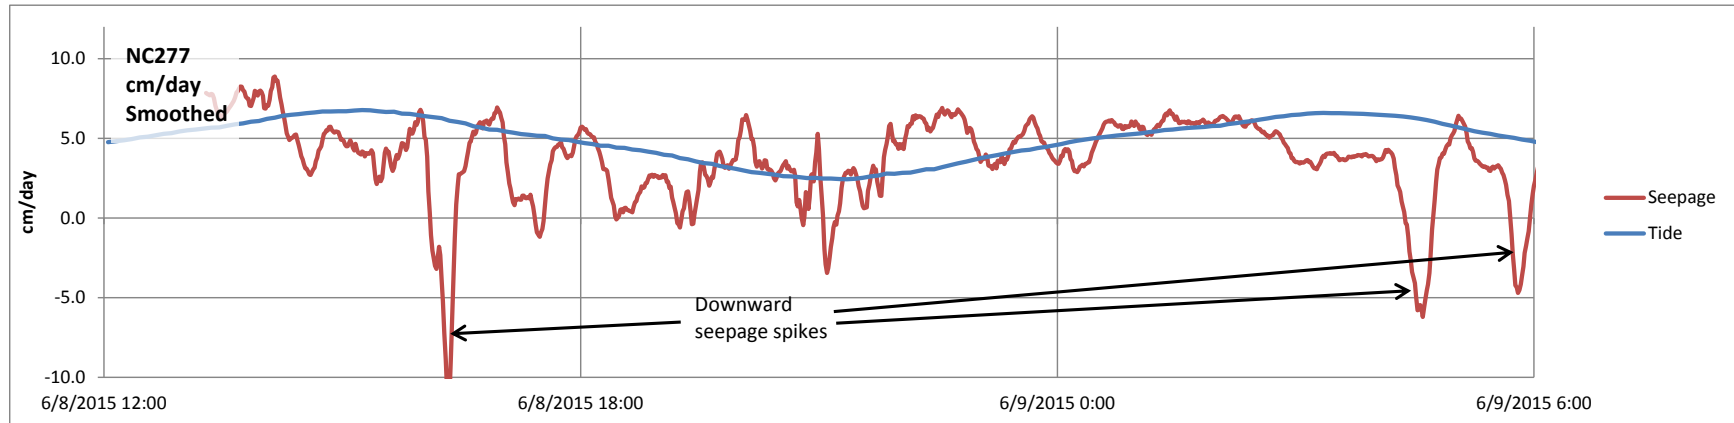
**Figure 16.** Smoothed seepage, in centimeters per day (cm/d), and relative tide, in feet, measured at NC277 showing three brief periods of substantial downward seepage.

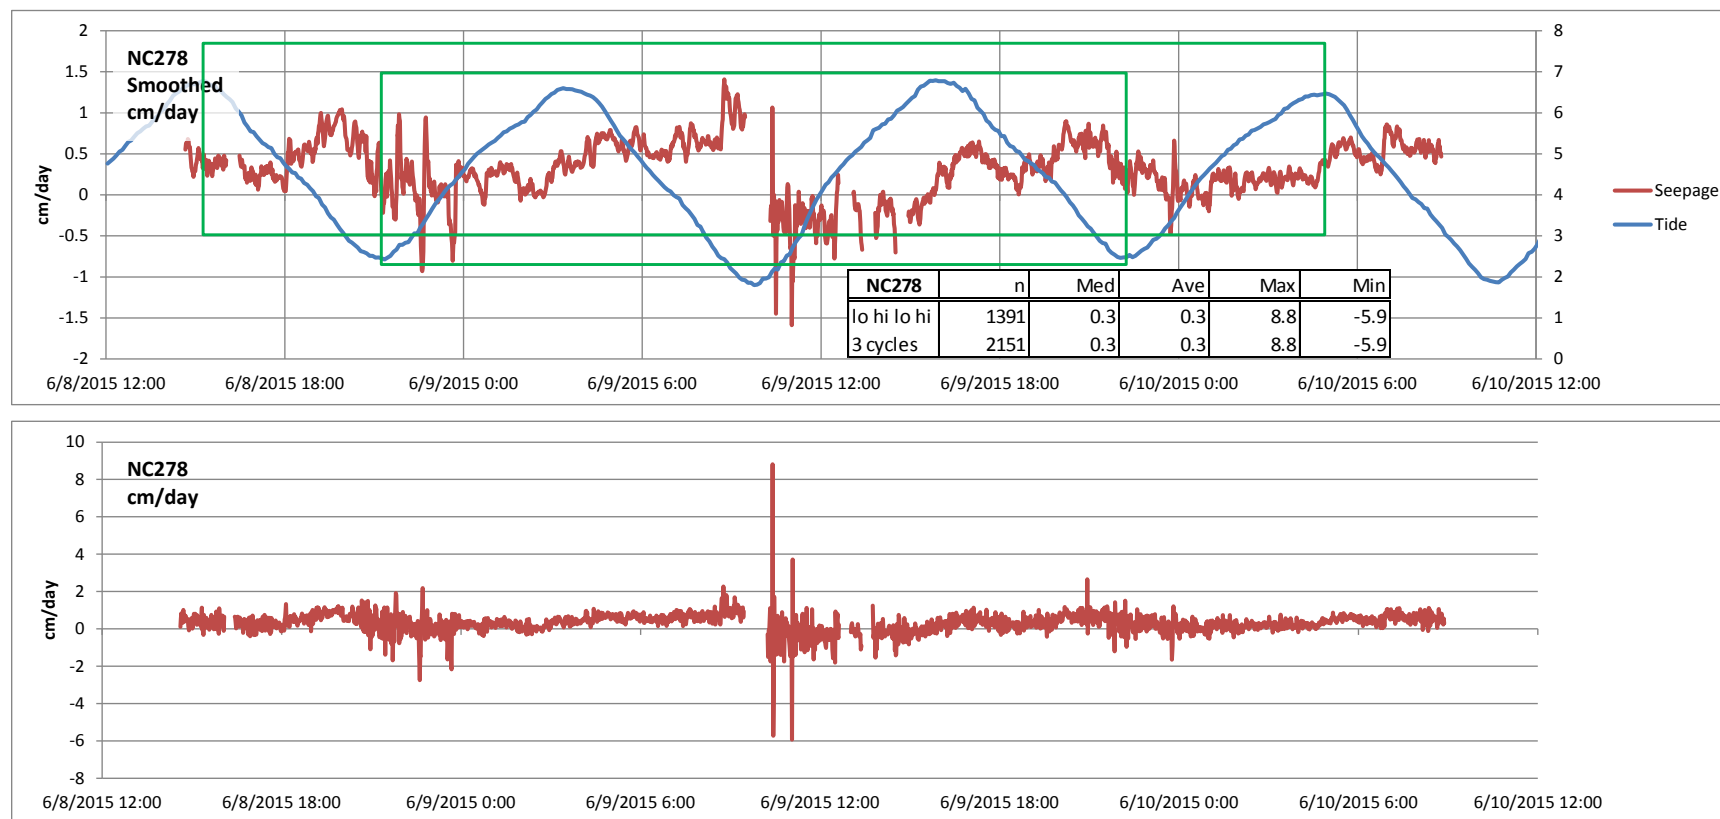
**Figure 17.** Seepage measured each minute during deployment at NC278, in centimeters per day. The upper plot displays smoothed data based on a 7-minute moving average, with relative tide, in feet, plotted on the right axis. The lower plot presents the actual 1-minute values. The green rectangles indicate the duration of the data-summary periods. In the inset table, “lo hi lo hi” indicates two complete tidal cycles beginning and ending with low tide, and “3 cycles” indicates that seepage was measured over three tidal cycles. (cm/d, centimeters per day; n, number of 1-minute values; Med, median of n values; Ave, average of n values; Max, maximum of n values; Min, minimum of n values)

Seepage was slow and mostly upward at NC278 with a median value of 0.3 cm/d and maximum values for downward and upward flow of -5.9 cm/d and 8.8 cm/d, respectively (fig. 17). Flow was zero to slightly downward for several hours following tidal nadir but was upward the rest of the measurement period. The upward spike at 10:25 on June 9, 2015, followed by a downward spike at 10:26, as shown in figure 18, may be related to the aforementioned 10:24 downward spike at NC277, which is located across the channel. The downward spike at 11:04 followed by an upward spike at 11:05 on June 9, 2015, may be related to passing barge traffic as described in detail for location NC271.

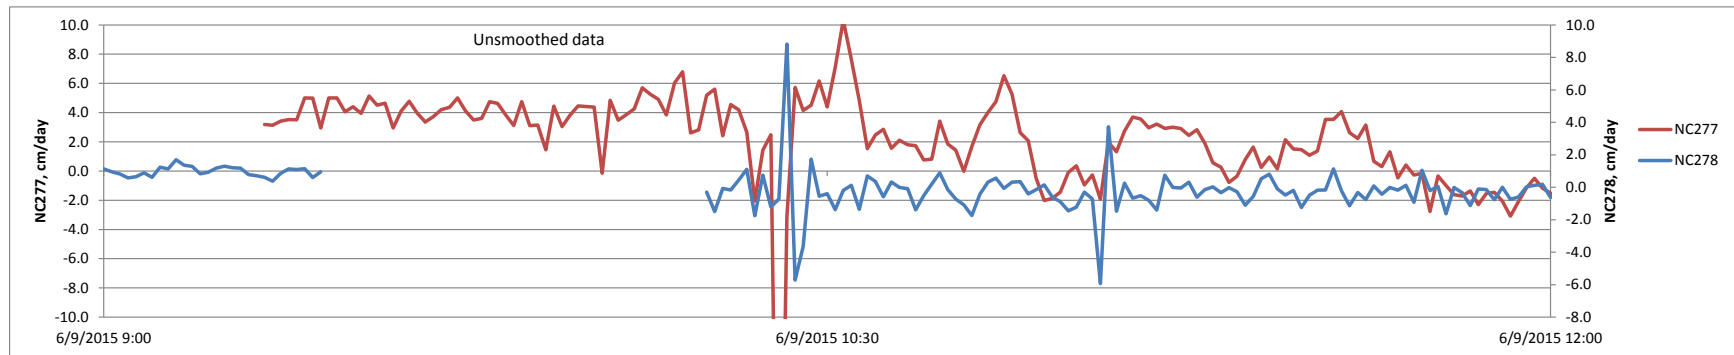
**Figure 18.** Unsmoothed seepage, in centimeters per day (cm/d), measured at NC277 (left axis) and NC278 (right axis).

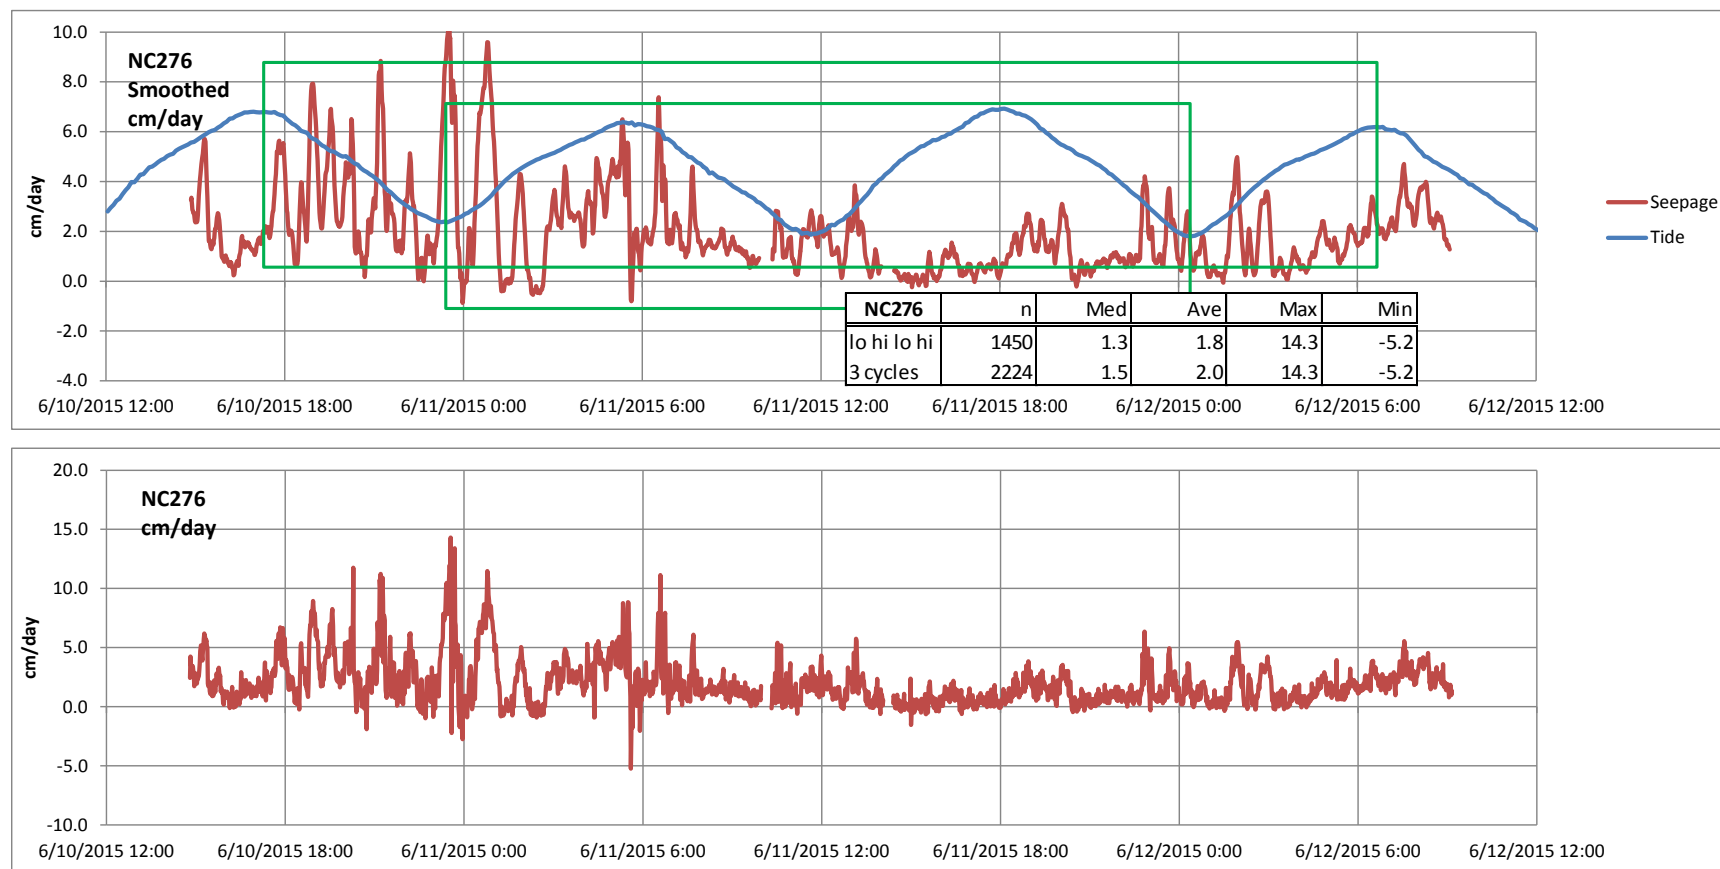
**Figure 19.** Seepage measured each minute during deployment at NC276, in centimeters per day. The upper plot displays smoothed data based on a 7-minute moving average, with relative tide, in feet, plotted on the right axis. The lower plot presents the actual 1-minute values. The green rectangles indicate the duration of the data-summary periods. In the inset table, “lo hi lo hi” indicates two complete tidal cycles beginning and ending with low tide, and “3 cycles” indicates that seepage was measured over three tidal cycles. (cm/d, centimeters per day; n, number of 1-minute values; Med, median of n values; Ave, average of n values; Max, maximum of n values; Min, minimum of n values)

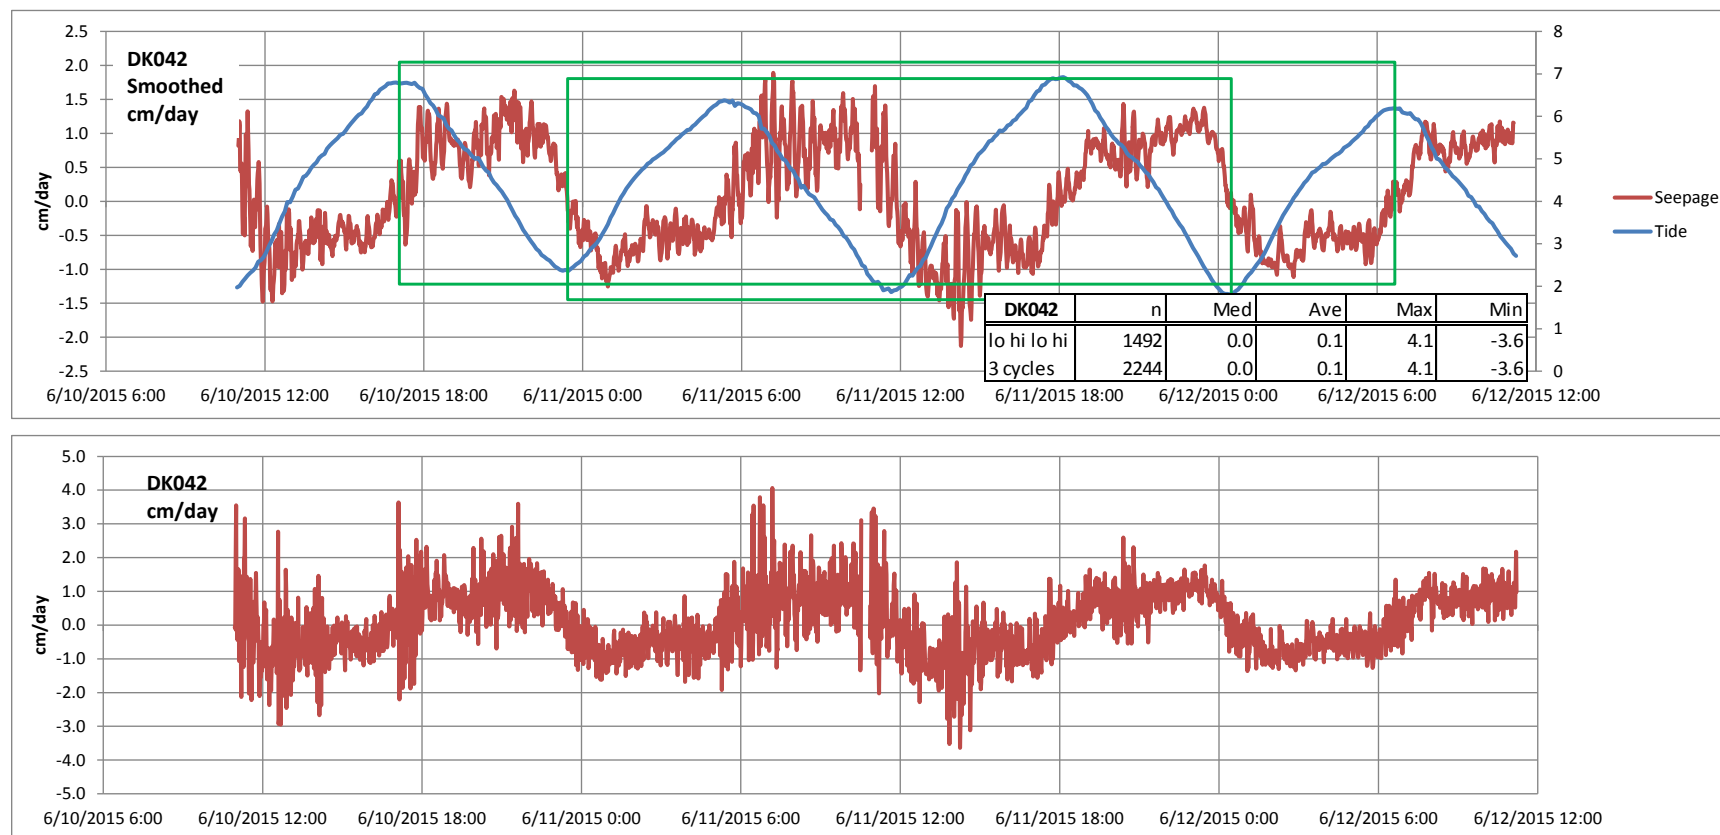
**Figure 20.** Seepage measured each minute during deployment at DK042, in centimeters per day. The upper plot displays smoothed data based on a 7-minute moving average, with relative tide, in feet, plotted on the right axis. The lower plot presents the actual 1-minute values. The green rectangles indicate the duration of the data-summary periods. In the inset table, “lo hi lo hi” indicates two complete tidal cycles beginning and ending with low tide, and “3 cycles” indicates that seepage was measured over three tidal cycles. (cm/d, centimeters per day; n, number of 1-minute values; Med, median of n values; Ave, average of n values; Max, maximum of n values; Min, minimum of n values)

DK042 is another site where seepage was small and only slightly variable. Median seepage was 0.0 cm/d, and values ranged from -3.6 to 4.1 cm/d during the 2-day data-collection period (fig. 20). However, seepage was strongly controlled by surface-water stage. Figure 21 shows a very good correlation between seepage and change in surface-water stage.

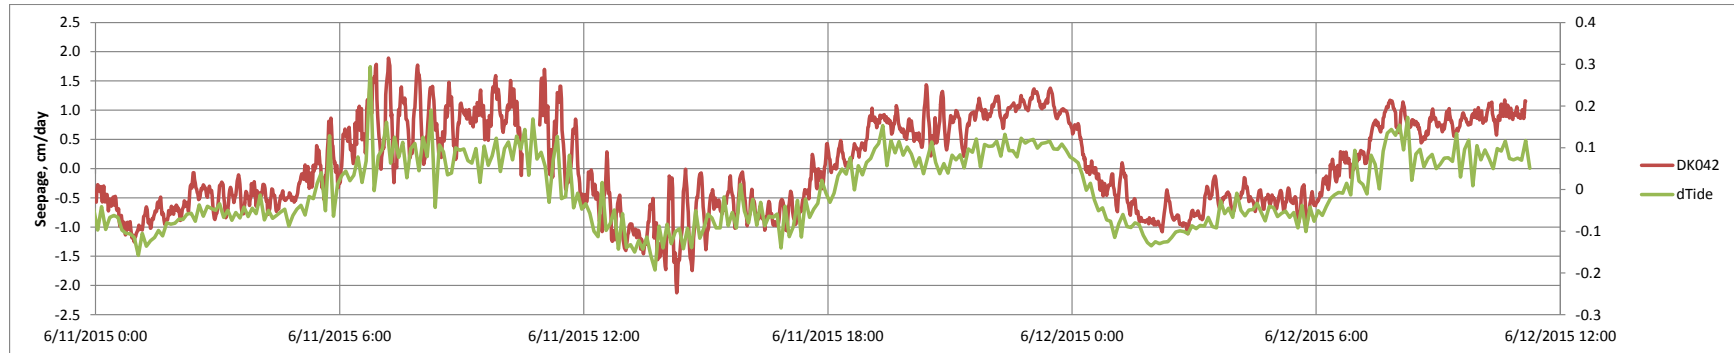
**Figure 21.** Smoothed seepage measured at DK042, in centimeters per day (cm/d), with the previous tidal value minus the current tidal value (dTide), in feet, plotted on the right axis.

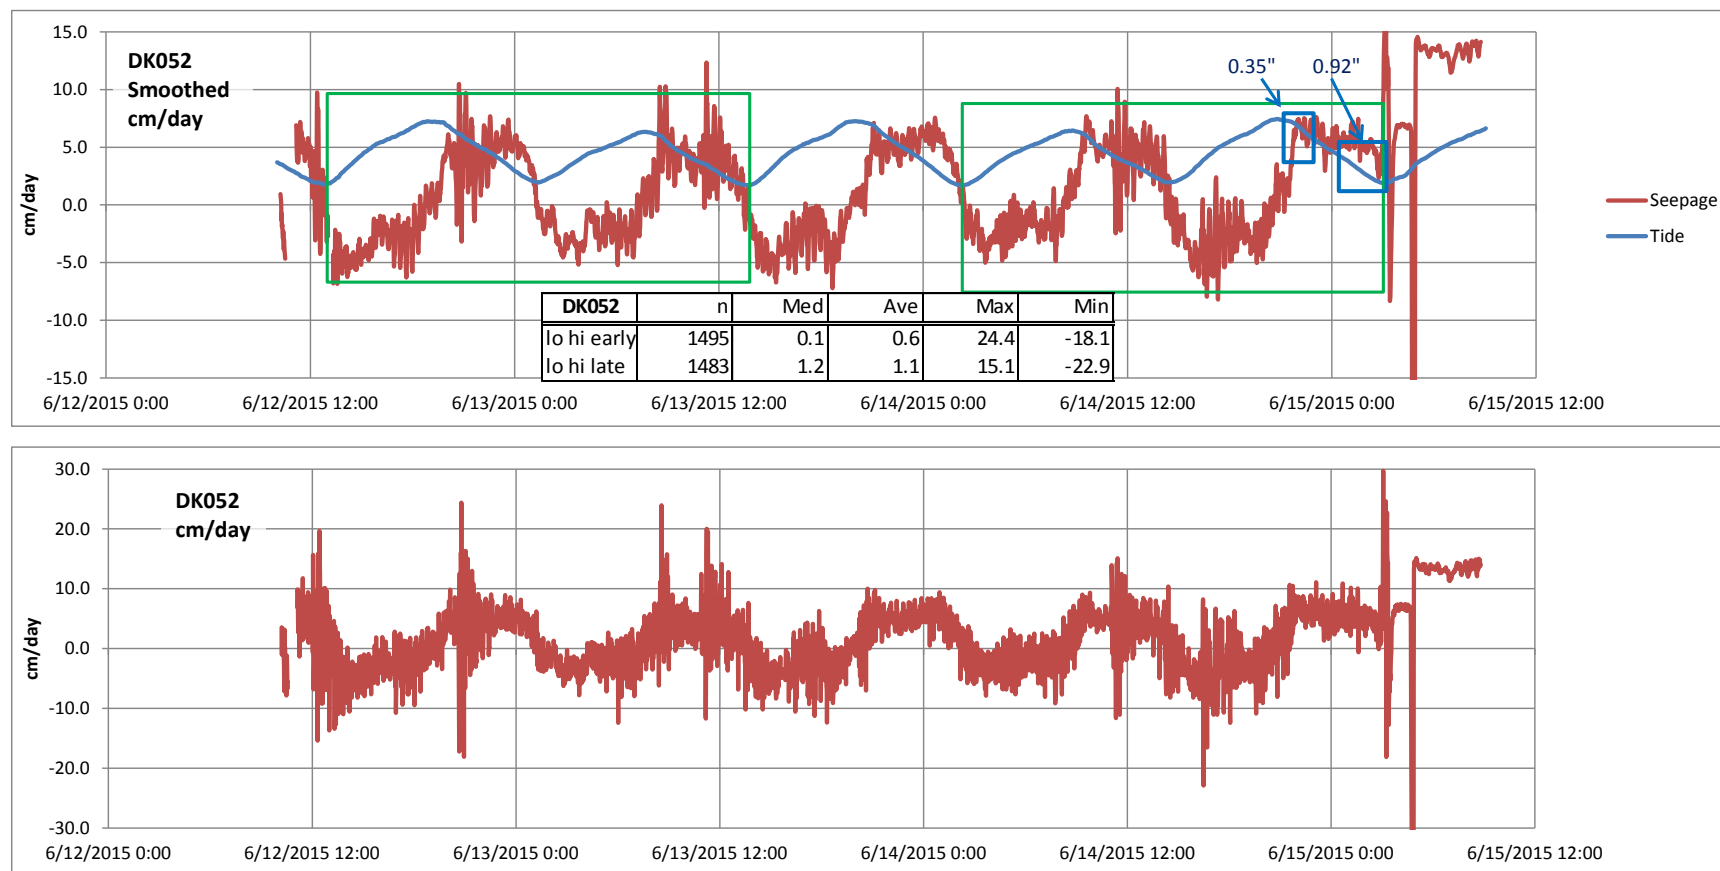
**Figure 22.** Seepage measured each minute during deployment at DK052, in centimeters per day. The upper plot displays smoothed data based on a 7-minute moving average, with relative tide, in feet, plotted on the right axis. The lower plot presents the actual 1-minute values. Blue rectangles in the upper plot indicate periods of rainfall with amounts indicated in inches. The green rectangles indicate the duration of the data-summary periods. In the inset table, “lo hi” indicates one complete tidal cycle beginning and ending with low tide, and “early” or “late” indicates timing of an analysis period relative to the site-specific data-collection period. (cm/d, centimeters per day; n, number of 1-minute values; Med, median of n values; Ave, average of n values; Max, maximum of n values; Min, minimum of n values)

Time-averaged seepage at DK052 also was very slow. Median seepage was 0.1 cm/d during the early part of the data-collection period (fig. 22). A slight increase in seepage occurred during the deployment. If the first four tidal cycles are analyzed, median seepage is 0.5 cm/d. However, possibly because rain fell during the last tidal cycle, median seepage during the last two tidal cycles increased to 1.2 cm/d. Rain has been shown elsewhere to substantially affect seepage rates (Rosenberry and others, 2013). Although seepage was small when averaged over time, seepage varied substantially in response to tides. This location, more than any other, had a remarkably large diurnal variability in seepage relative to the time-averaged value. Maximum downward and upward seepage were -22.9 cm/d and 24.4 cm/d, respectively. Seepage was also strongly controlled by subtle changes in surface-water stage, as seen in figure 23 where dTide is plotted on the right axis.

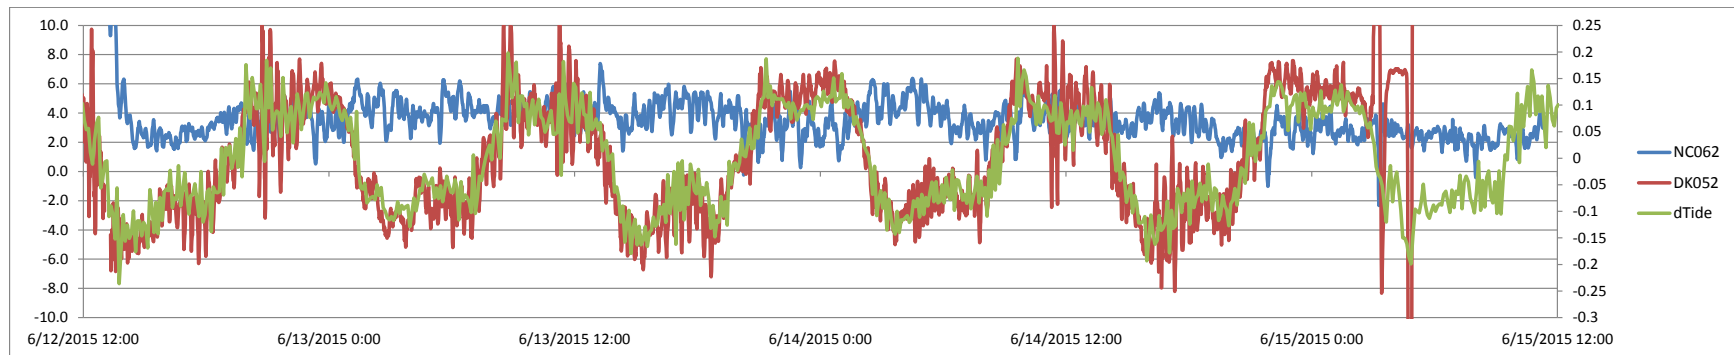
**Figure 23.** Smoothed seepage measured at DK052 and NC062, in centimeters per day (cm/d), with the previous tidal value minus the current tidal value (dTide), in feet, plotted on the right axis.

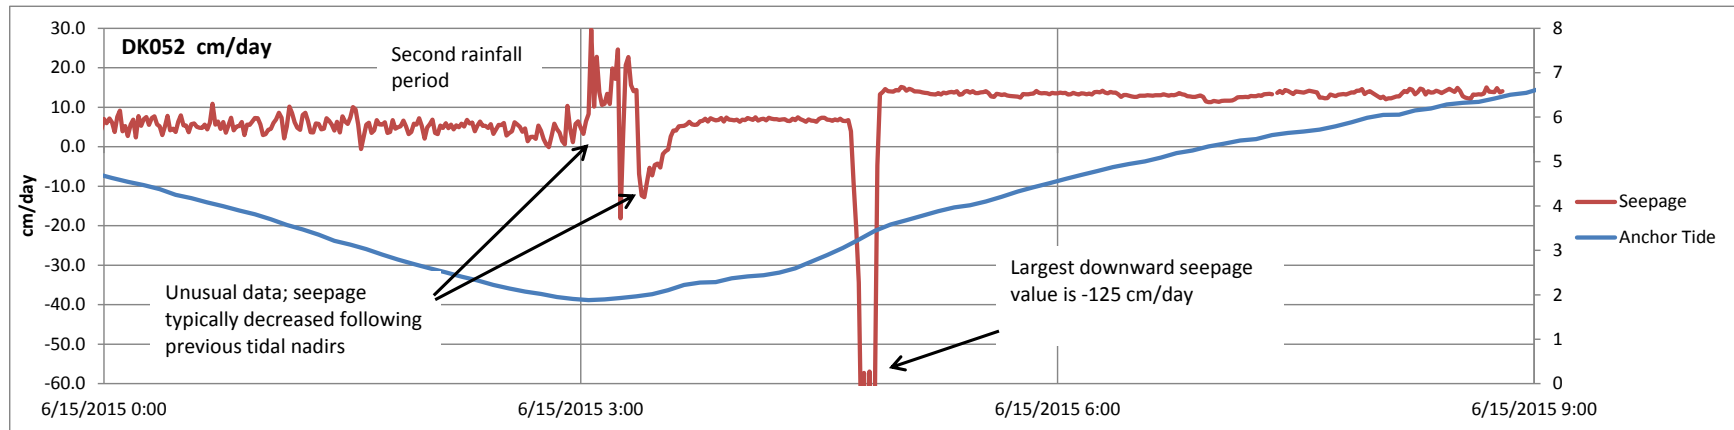
**Figure 24.** Smoothed seepage measured at DK052, in centimeters per day (cm/d), with relative tide measured at the Anchor dock, in feet, plotted on the right axis.

The unusual data collected from 03:04 to about 03:37 (fig. 24) are also difficult to interpret. These perturbations could be due to ebullition, seepage-related noise caused by rain and (or) lightning, or waves associated with a windy period. No matter the cause, this period was a substantial departure from previous seepage trends when seepage would sharply decrease prior to and following tidal nadir. Low tide occurred at 03:03 on June 15, 2015, at the tide gage next to the Anchor dock.

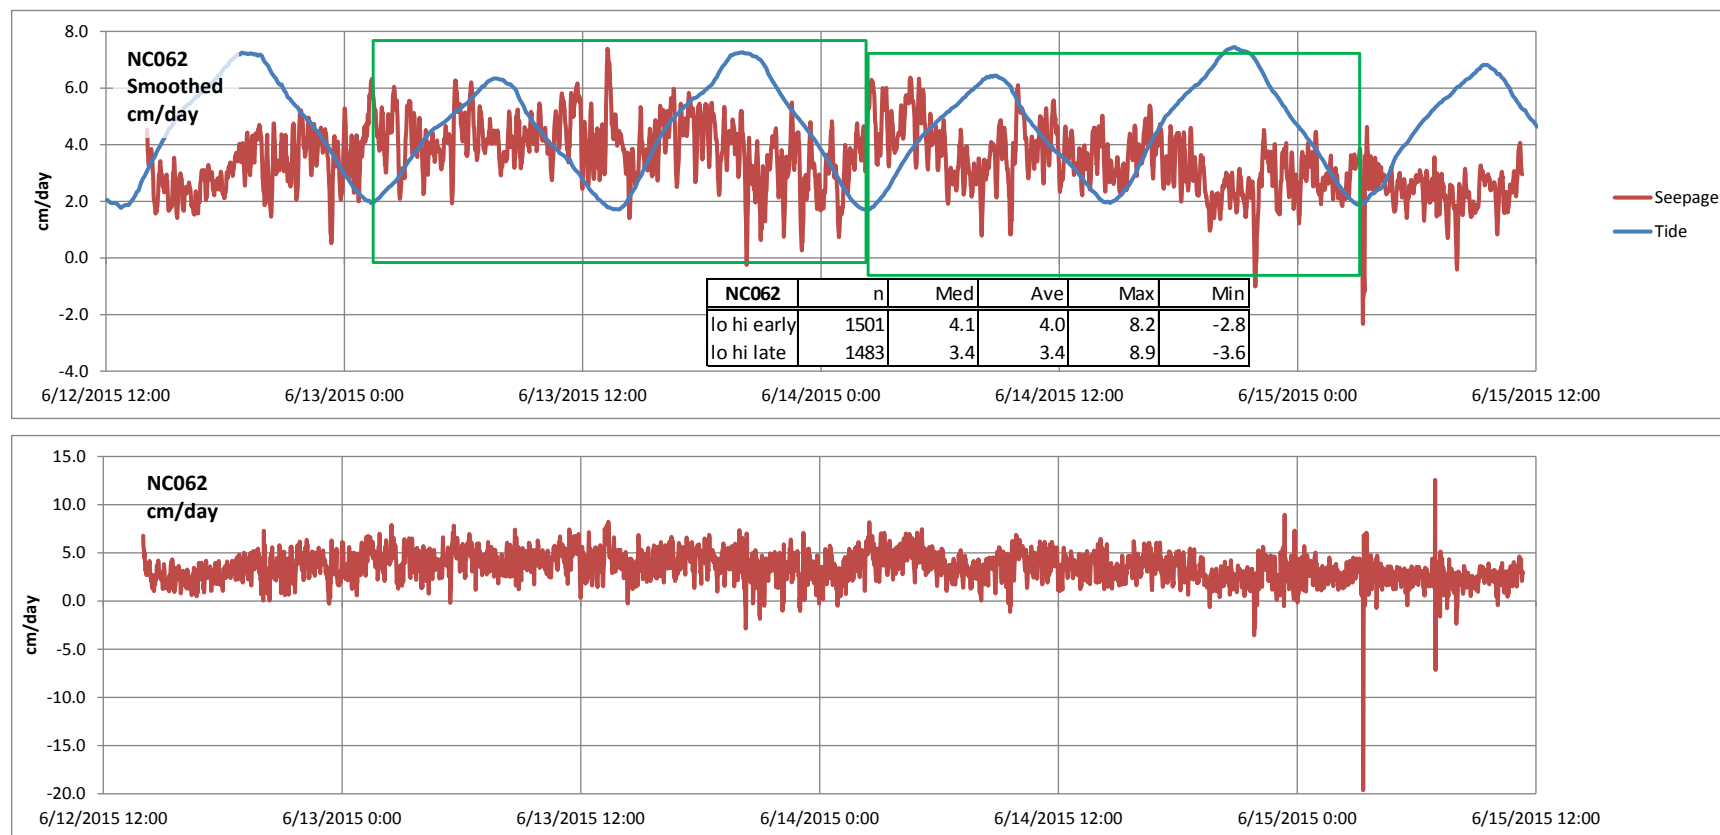
**Figure 25.** Seepage measured each minute during deployment at NC062, in centimeters per day. The upper plot displays smoothed data based on a 7-minute moving average, with relative tide, in feet, plotted on the right axis. The lower plot presents the actual 1-minute values. The green rectangles indicate the duration of the data-summary periods. In the inset table, “lo hi” indicates one complete tidal cycle beginning and ending with low tide, and “early” or “late” indicates timing of an analysis period relative to the site-specific data-collection period. (cm/d, centimeters per day; n, number of 1-minute values; Med, median of n values; Ave, average of n values; Max, maximum of n values; Min, minimum of n values)

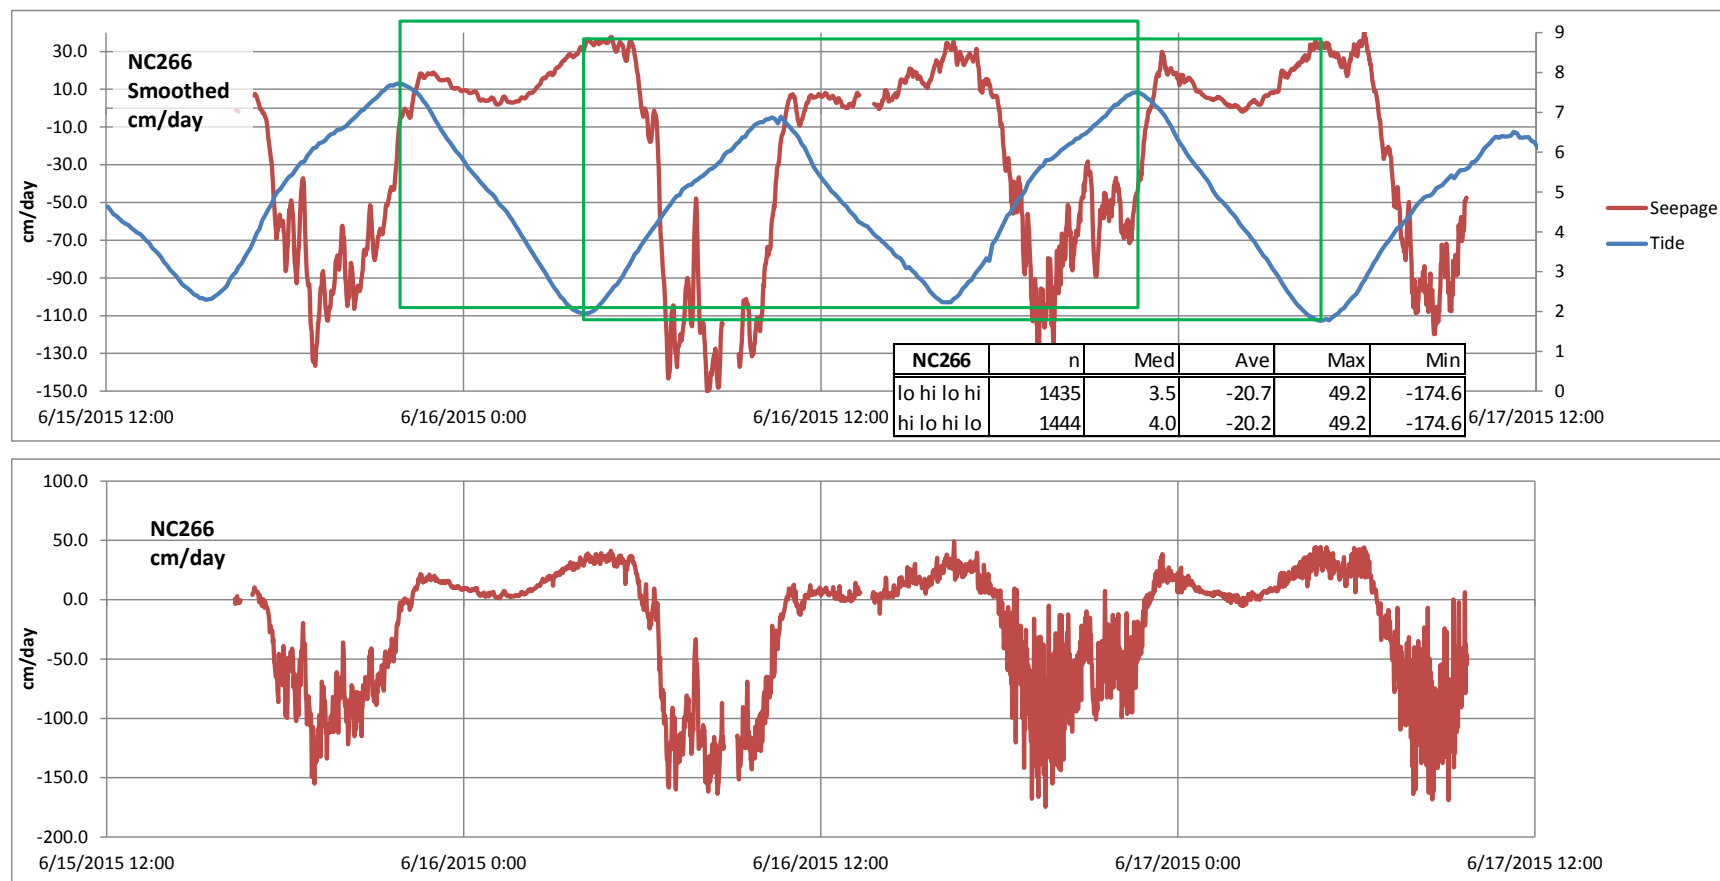
**Figure 26.** Seepage measured each minute during deployment at NC266, in centimeters per day. The upper plot displays smoothed data based on a 7-minute moving average, with relative tide, in feet, plotted on the right axis. The lower plot presents the actual 1-minute values. The green rectangles indicate the duration of the data-summary periods. In the inset table, “lo hi” indicates one complete tidal cycle beginning and ending with low tide, and “hi lo” indicates one complete tidal cycle beginning and ending with high tide. (cm/d, centimeters per day; n, number of 1-minute values; Med, median of n values; Ave, average of n values; Max, maximum of n values; Min, minimum of n values; cyc, cycles)

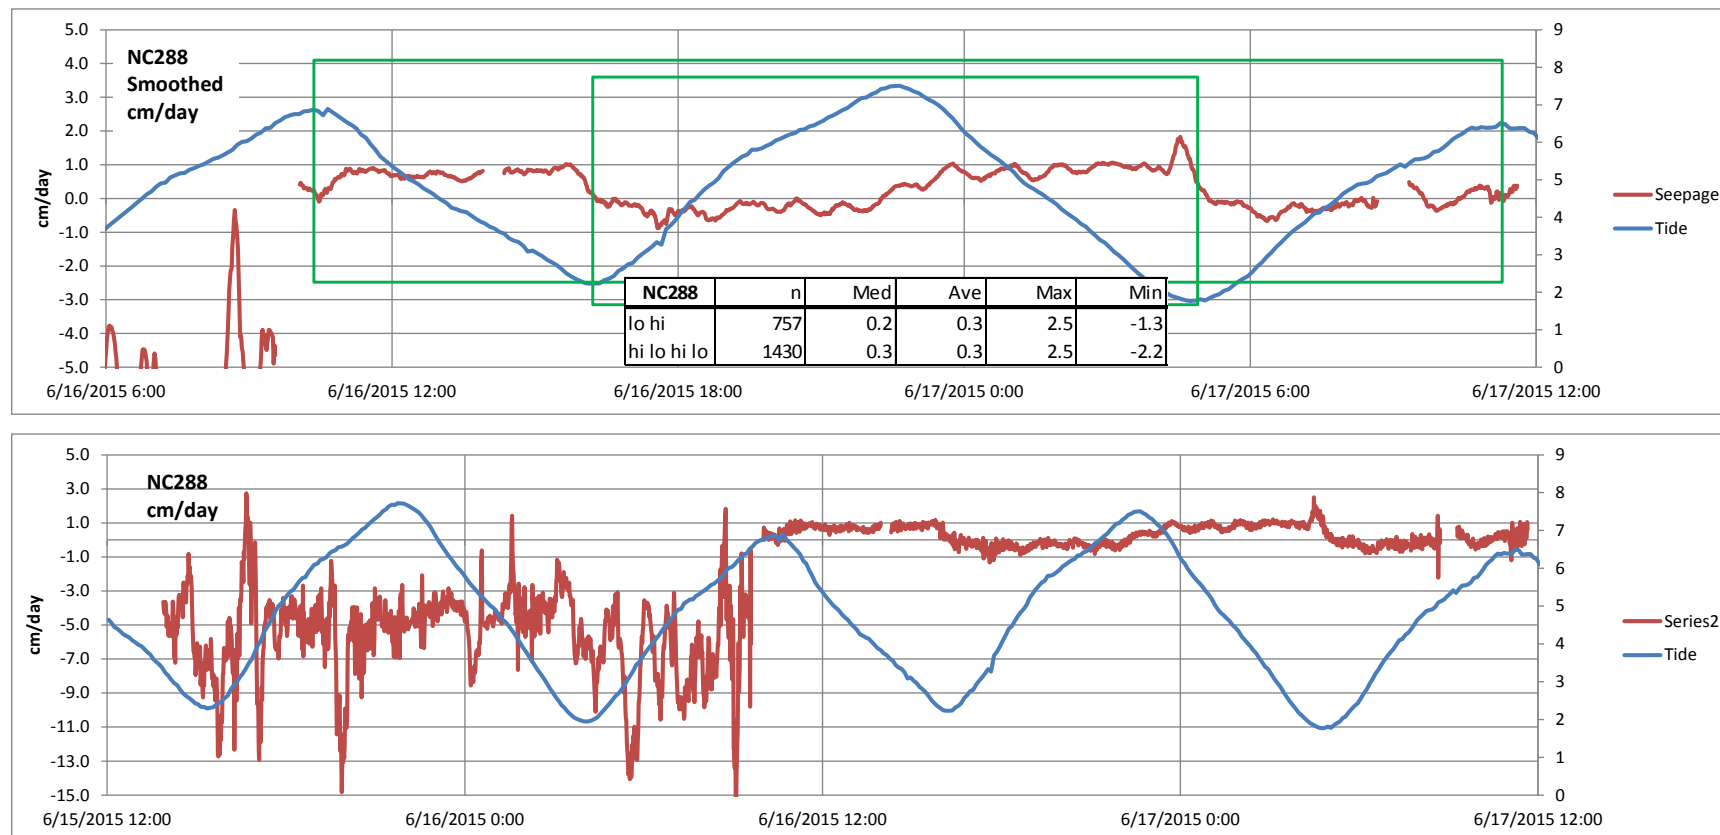
**Figure 27.** Seepage measured each minute during deployment at NC288, in centimeters per day. The upper plot displays smoothed data based on a 7-minute moving average, with relative tide, in feet, plotted on the right axis. The lower plot presents the actual 1-minute values. The green rectangles indicate the duration of the data-summary periods. In the inset table, “lo hi” indicates one complete tidal cycle beginning and ending with low tide, and “hi lo” indicates one complete tidal cycle beginning and ending with high tide. (cm/d, centimeters per day; n, number of 1-minute values; Med, median of n values; Ave, average of n values; Max, maximum of n values; Min, minimum of n values; cyc, cycles)

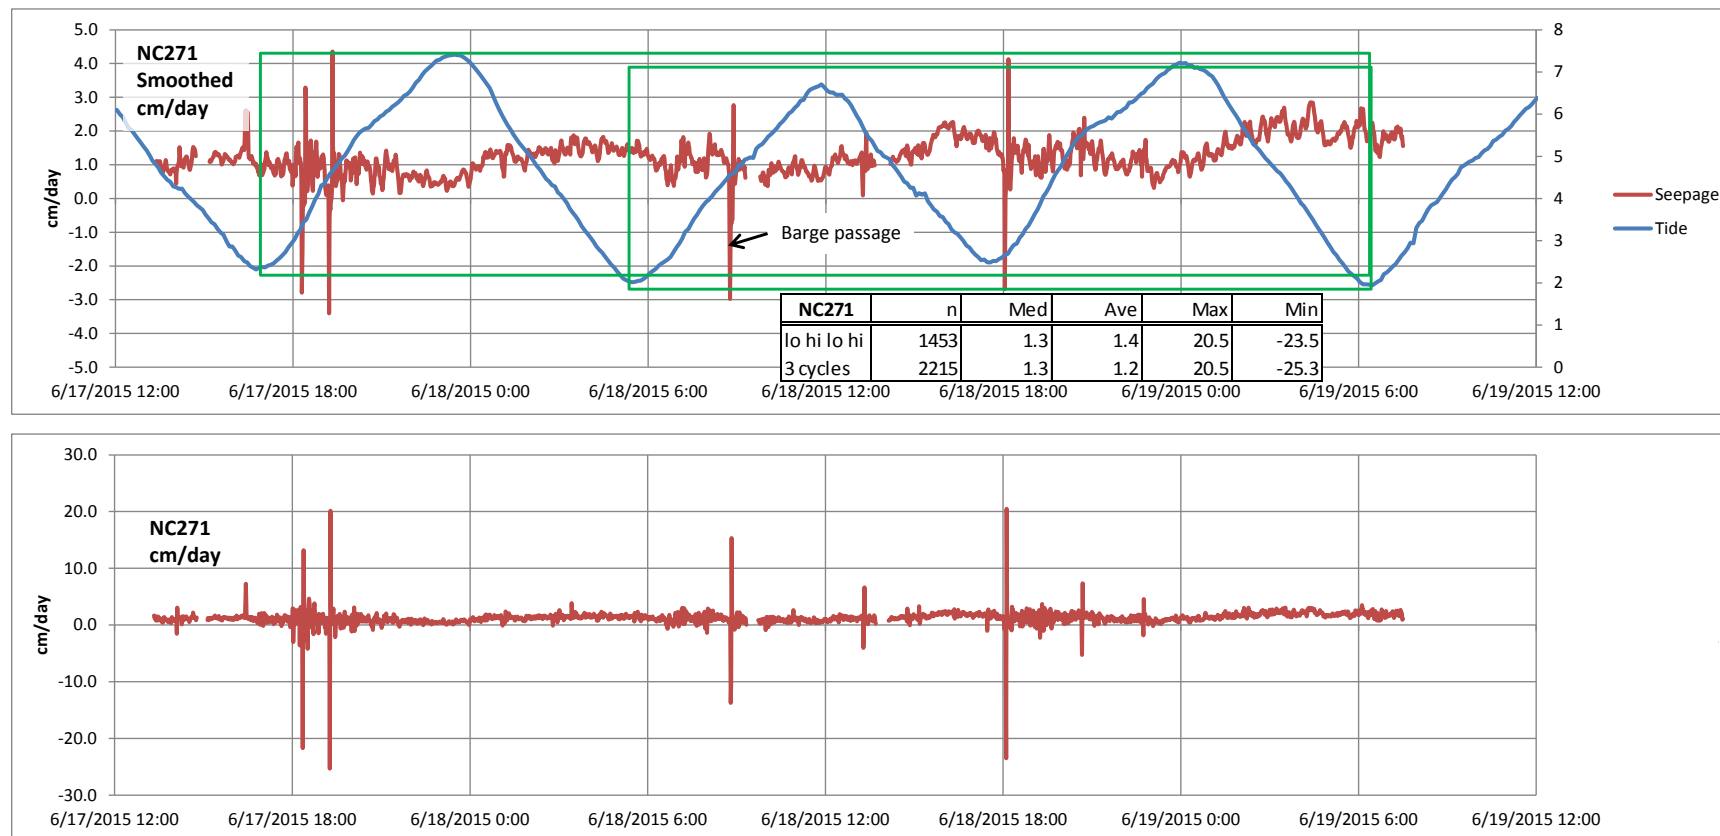
**Figure 28.** Seepage measured each minute during deployment at NC271, in centimeters per day. The upper plot displays smoothed data based on a 7-minute moving average, with relative tide, in feet, plotted on the right axis. The lower plot presents the actual 1-minute values. The green rectangles indicate the duration of the data-summary periods. In the inset table, “lo hi lo hi” indicates two complete tidal cycles beginning and ending with low tide, and “3 cycles” indicates that seepage was measured over three tidal cycles. (cm/d, centimeters per day; n, number of 1-minute values; Med, median of n values; Ave, average of n values; Max, maximum of n values; Min, minimum of n values)

Seepage was slow but consistently upward at NC271 (fig. 28). Median values were 1.3 and 1.3 cm/d for the two summary periods, with largest downward and upward seepage rates of -25.3 cm/d and 20.5 cm/d, respectively. However, these large extremes were almost certainly due to barge traffic. We were at NC271 and noted the passage of a barge on June 18, 2015, from 08:47 to 08:51 while observing a coincident downward then upward spike in measured seepage. A similar spike appears in the NC272 dataset, offset by one minute (fig. 29), as the same barge passed by that location. If the known and likely barge-generated spikes are removed, extreme values during the data-analysis periods are -4.2 and 4.7 cm/d. A small tidal response is evident; seepage increased for several hours following the high-tide apex and generally decreased slowly starting within an hour of low tide.

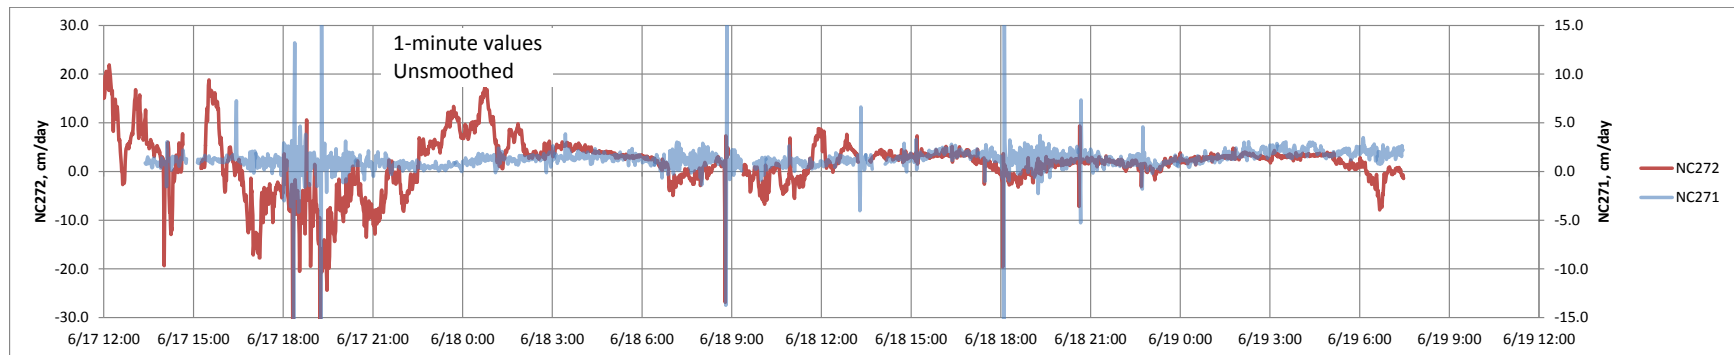
**Figure 29.** Unsmoothed seepage, in centimeters per day (cm/d), measured at NC272 (left axis) and NC271 (right axis).

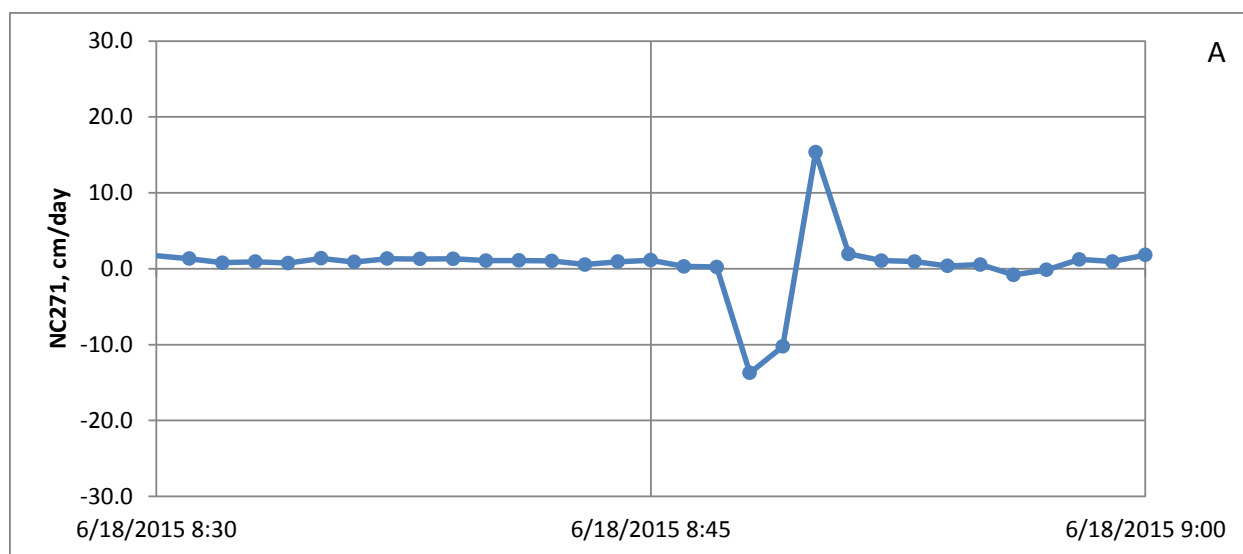
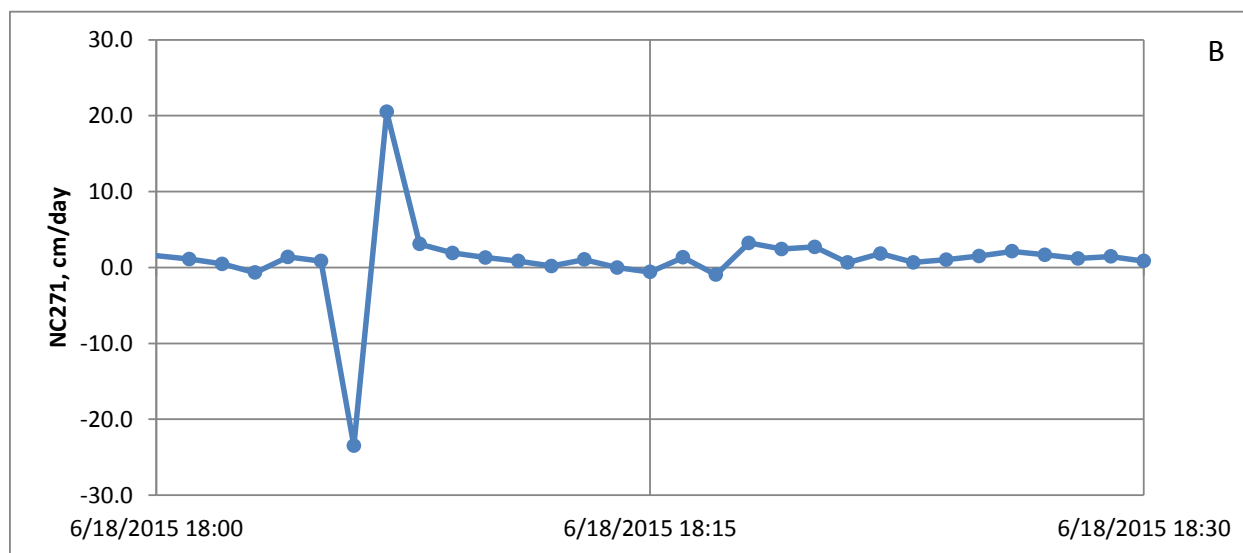
**Figure 30.** Seepage determined each minute (unsmoothed) at NC271, in centimeters per day (cm/d), on June 18, 2015, during (A) 08:30–09:00 and (B) 18:00–18:30.

Several times at several locations during seepage-meter deployment, it was suspected that brief intervals of large departures in measured seepage were caused by passing boat traffic. As mentioned earlier, the crew was anchored near NC271 on the morning of June 18, 2015, when a barge passed by. The effect on seepage is shown in detail in figure 30A. As the barge approached, downward seepage occurred. When the passing barge was closest to the seepage meter, measured seepage changed from being downward to neutral and then to upward within 10–15 seconds. Positive seepage occurred as the barge moved beyond and away from the seepage-measurement location. The effect lasted only a few minutes. Instantaneous 5-second values ranged from -215 cm/d to approximately 100 cm/d during the 08:49 barge passage on June 18, 2015. Another barge passage later that same day is also evident in the data; the effect is shown in figure 30B.
