# Seepage Measured at 17 Locations in Newtown Creek, New York

## U.S. Geological Survey Administrative Report to U.S. Environmental Protection Agency, Special Projects Branch, New York, New York

Data collected May 19–June 19, 2015

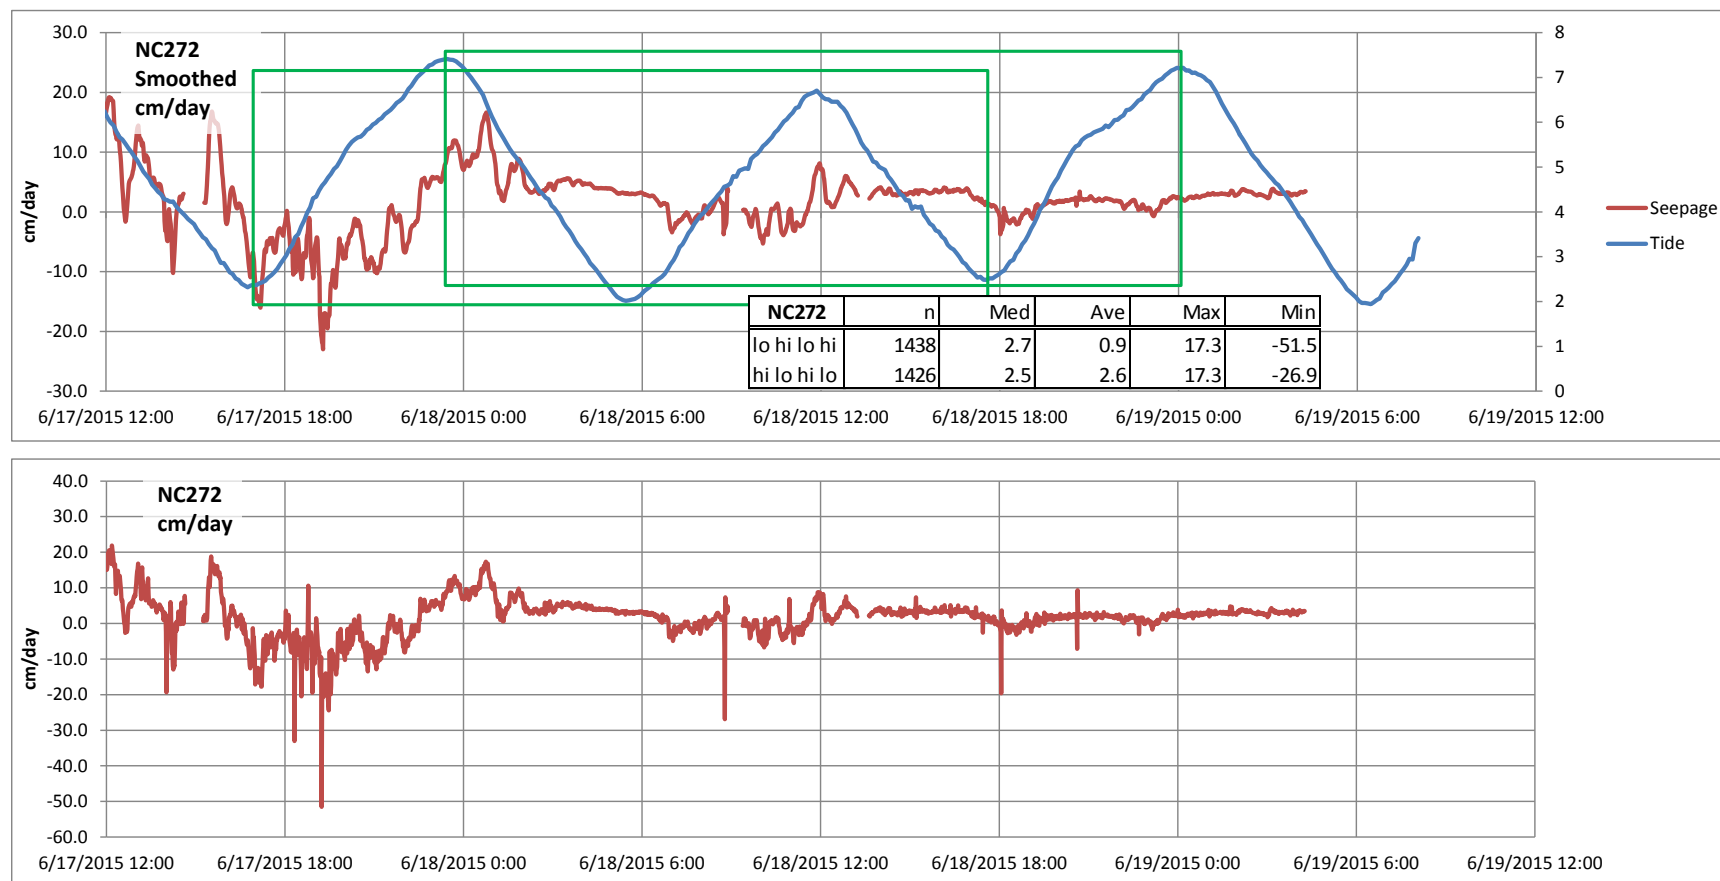
**Figure 31.** Seepage measured each minute during deployment at NC272, in centimeters per day. The upper plot displays smoothed data based on a 7-minute moving average, with relative tide, in feet, plotted on the right axis. The lower plot presents the actual 1-minute values. The green rectangles indicate the duration of the data-summary periods. In the inset table, “lo hi lo hi” indicates two complete tidal cycles beginning and ending with low tide, and “hi lo hi lo” indicates two complete tidal cycles beginning and ending with high tide. (cm/d, centimeters per day; n, number of 1-minute values; Med, median of n values; Ave, average of n values; Max, maximum of n values; Min, minimum of n values)

The relatively noisy data during the first 12 hours of deployment at NC272 (fig. 31) are difficult to interpret; the cause for this greater variability is unknown. The decrease in seepage during the first 5 hours may indicate seepage coming into equilibrium following sediment disturbance during meter insertion. However, data collected starting after midnight on June 18, 2015, appear reasonable and are similar to data from many of the other locations at Newtown Creek. The data-analysis period that begins with high tide largely excludes the perhaps questionable early noisy data. Median seepage for that period is 2.5 cm/d with extreme values ranging from -26.9 to 17.3 cm/d. The data-analysis period that does include much of the early noisy data has a nearly identical median seepage rate of 2.7 cm/d. As at the NC271 site, exclusion of the large negative spikes caused by barge traffic greatly decreases the range of the seepage data.
